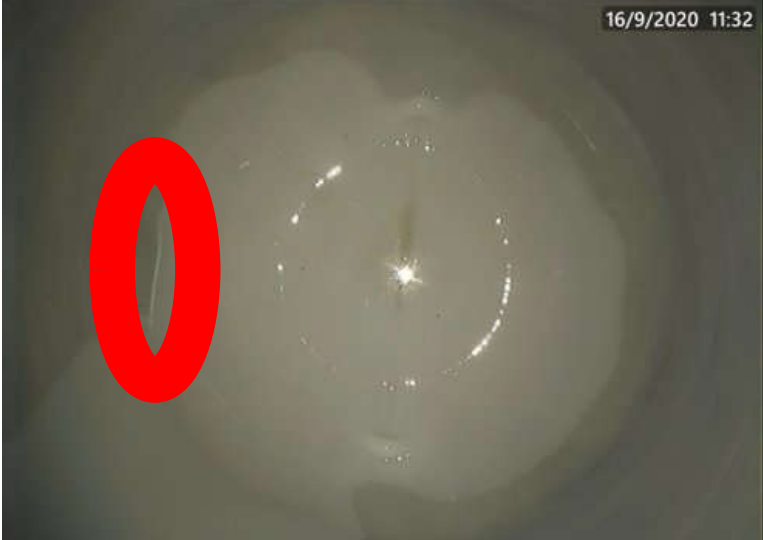
<p>Stretch-mark / white line in the liner at cylindrical / dome transition area (internal inspection). Usually in combination with partial lack of adhesion between liner and composite wrapping.</p>	<p>Reject</p>

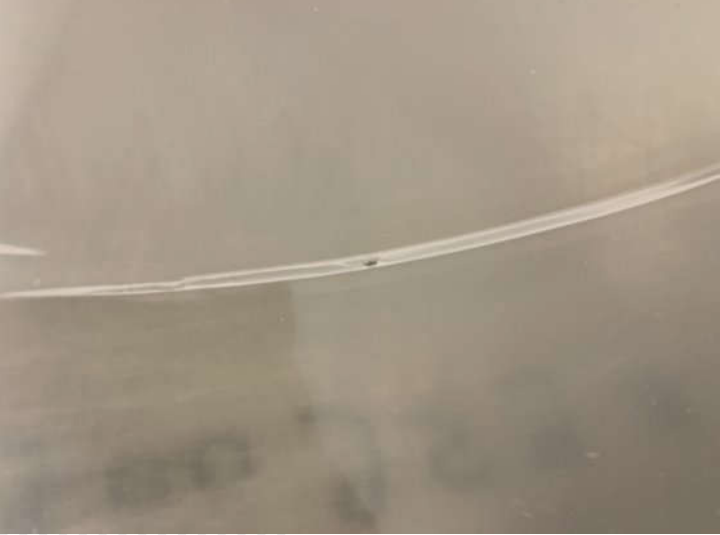
<p>Stretch-mark / white line in the liner at cylindrical / dome transition area (internal inspection). Usually in combination with partial lack of adhesion between liner and composite wrapping (whitish area in the picture).</p>	<p>Reject</p>
