# Composite LPG cylinders

## Appendix 1 – Criteria for cylinder inspection

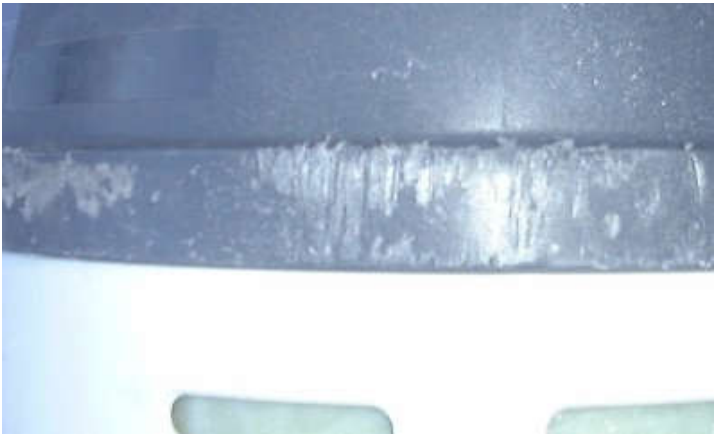
| | <p>Damage on handle "skirt",<br/>and potentially casing lower<br/>part.</p> | <p>Replace handle<br/>and potentially<br/>casing lower<br/>part.</p> |

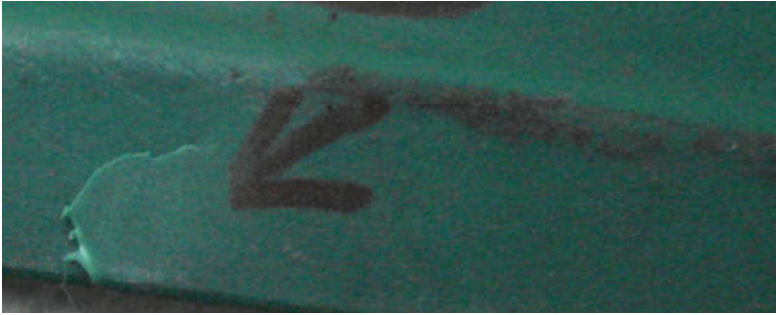
| | <p>Damage on handle "skirt", typically beside the snap</p> | <p>Replace handle</p> |

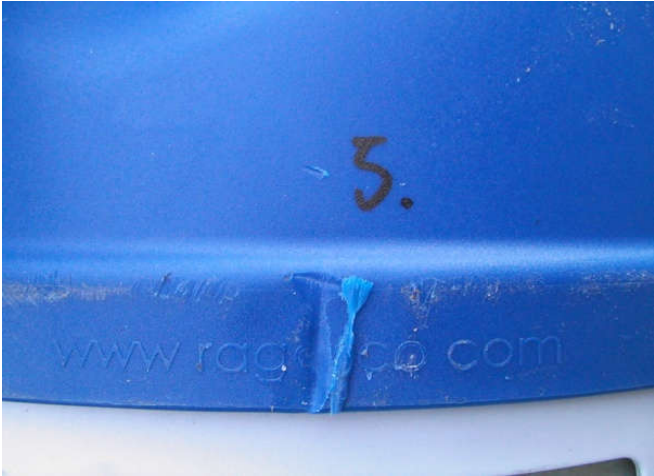
| | <p>Damage on handle "skirt" and potentially casing lower part.</p> | <p>Replace handle and casing lower part.</p> |

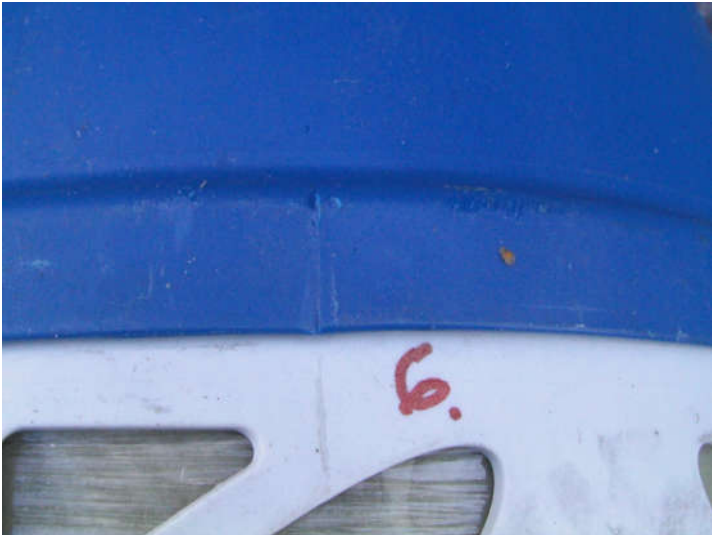
| | <p>Damage on handle "skirt" and casing lower part.</p> | <p>Replace handle and casing lower part.</p> |

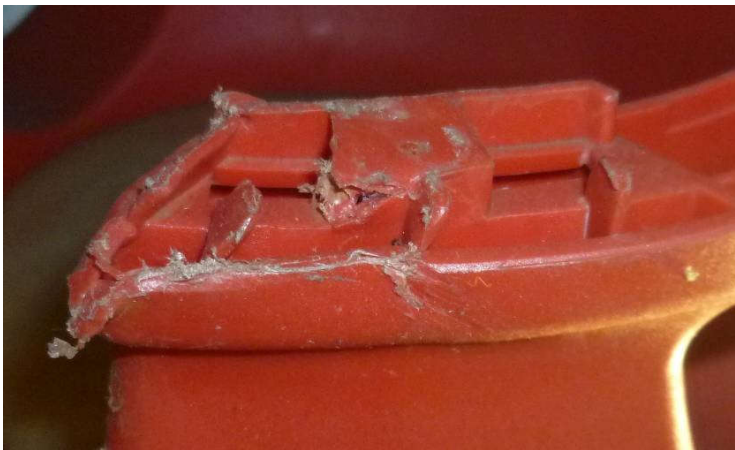
| | <p>Ring and handle part broken<br/>→ impossible to replace ring</p> <p><small>Photo courtesy of PrestaCylinders</small></p> | <p>Replace ring and handle</p> |

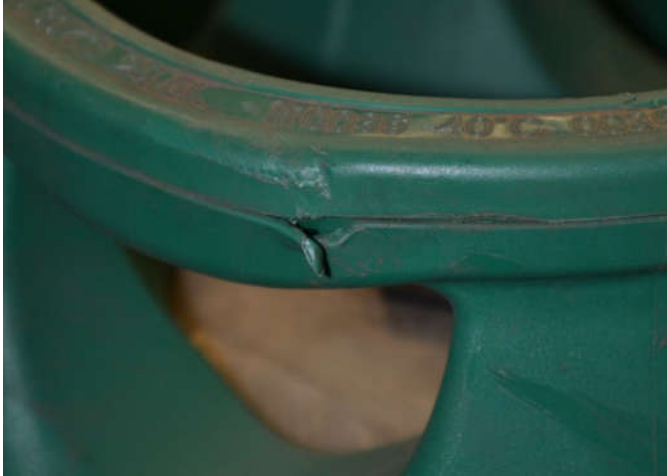
| | <p>Crack on ring and handle part. Potentially rough handling.</p> <p><small>Photo courtesy of PrestaCylinders</small></p> | <p>Replace ring and handle.</p> |

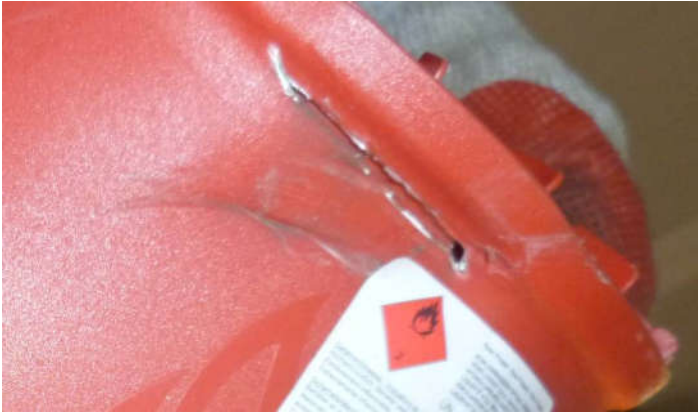
| | <p>Ring and handle damaged</p> <p><small>Photo courtesy of PrestaCylinders</small></p> | <p>Replace ring and handle</p> |

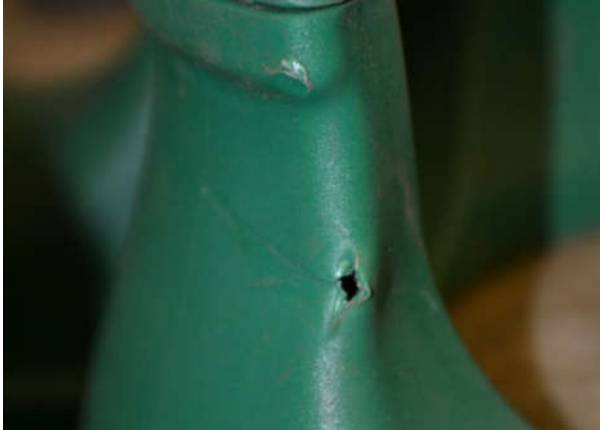
| | <p>Impact on handle part of casing</p> <p><small>Photo courtesy of PrestaCylinders</small></p> | <p>Replace handle</p> |

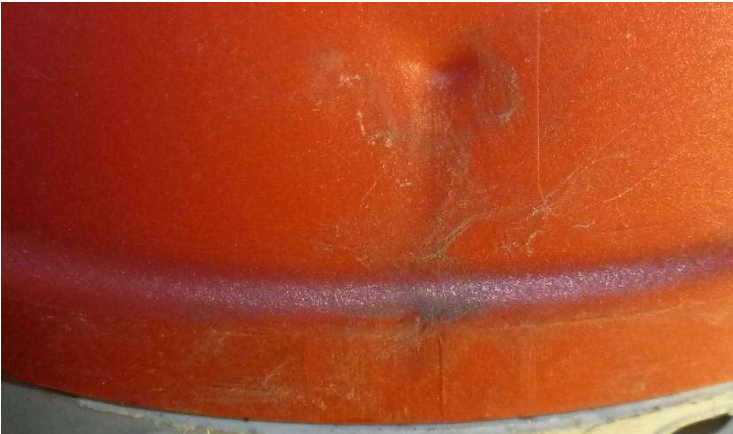
| | <p>Impact on handle part and potentially casing lower part</p> | <p>Replace handle and casing lower part</p> |

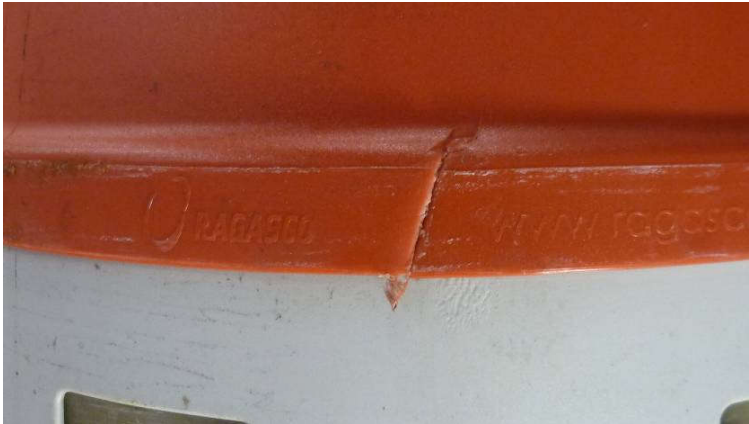
| | <p>Impact on handle part and potentially casing lower part</p> | <p>Replace handle and casing lower part</p> |

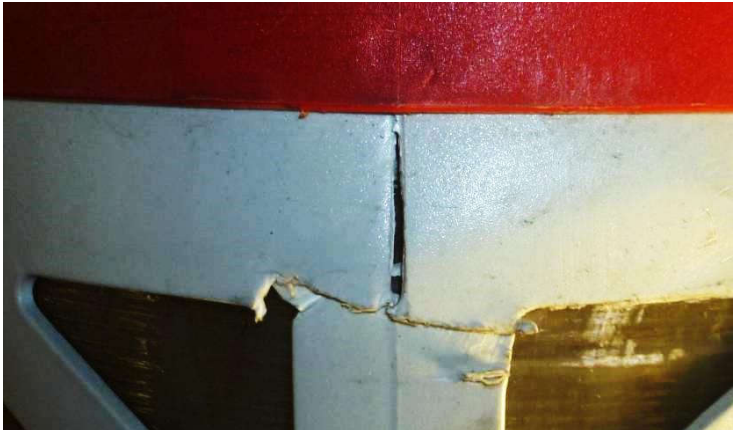
| | <p>Composite damaged due to impact or abrasion. Casing lower part broken, potentially also snap on handle part.</p> | <p>Reject.</p> |

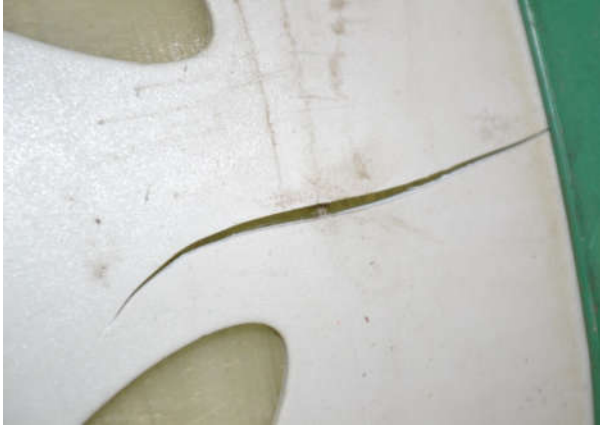
| | <p>Casing lower part broken because of composite uneven surface.</p> <p><small>Photo courtesy of PrestaCylinders</small></p> | <p>No action</p> |

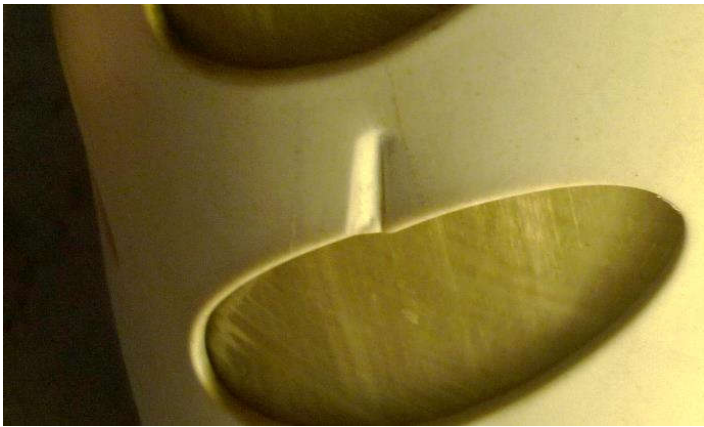
| | <p>Damage to casing lower part. No visual impact on fibre.</p> <p><small>Photo courtesy of PrestaCylinders</small></p> | <p>Replace casing lower part.</p> |

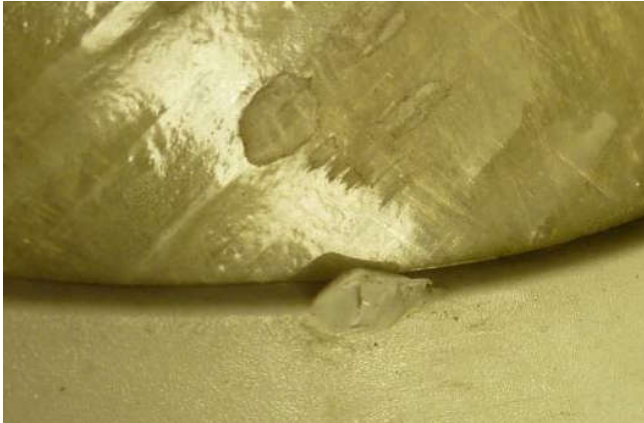
| | <p>Damage to fibre and casing lower part.</p> <p><small>Photo courtesy of PrestaCylinders</small></p> | <p>Reject</p> |

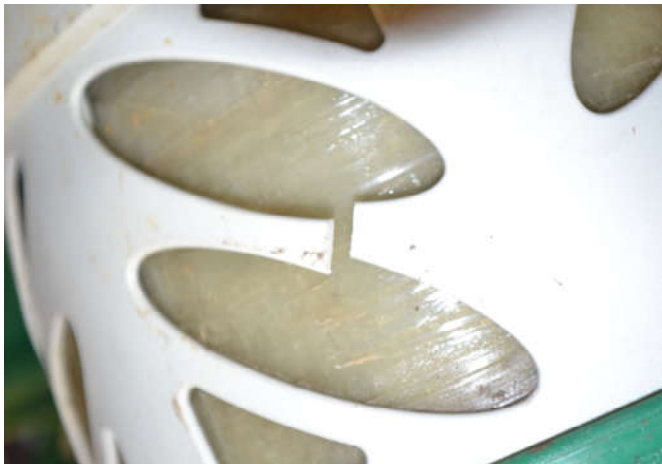
| | <p>Casing lower part broken without any sign of impact</p> | <p>No action</p> |

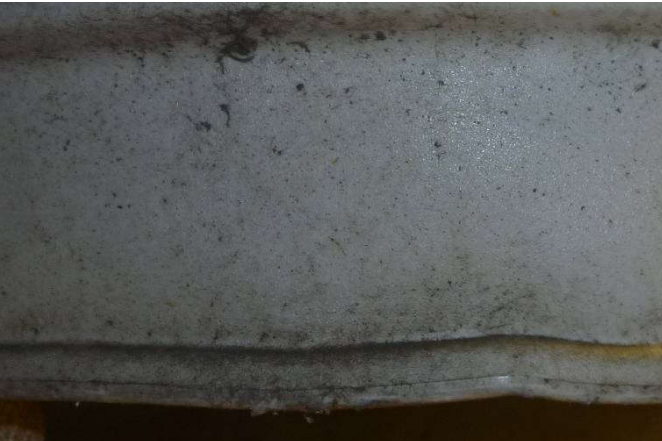
| | <p>Casing lower part foot-ring deformed (no cracks in the bottom area casing or composite detected)</p> | <p>No action</p> |

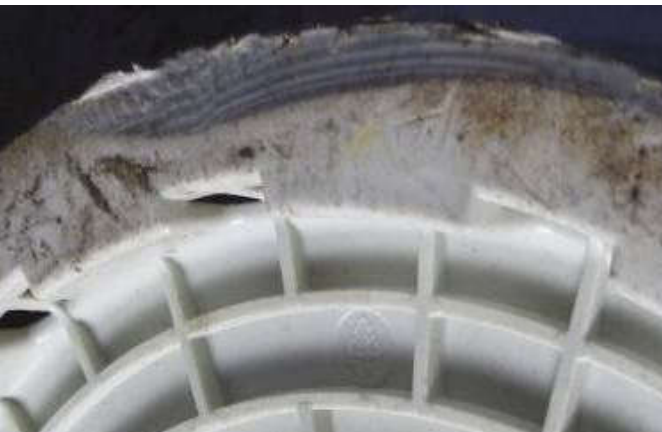
| | <p>Casing lower part foot-ring deformed (no cracks in the bottom area casing or composite detected)</p> | <p>No action</p> |

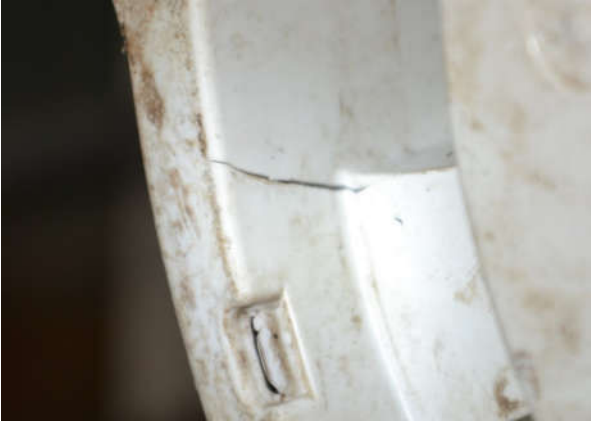
| | <p>Casing lower part foot-ring cracked</p> | <p>Replace casing lower part.</p> |

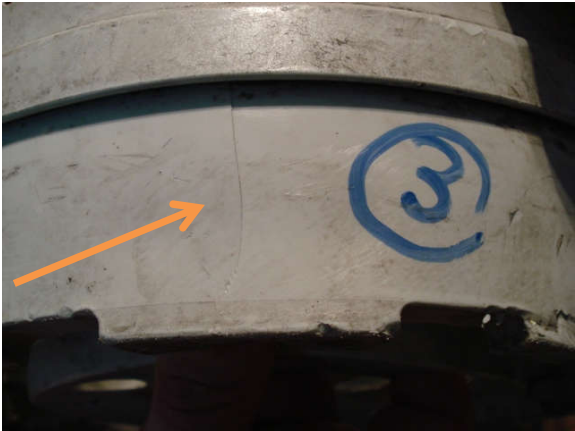
| | <p>Casing lower part foot-ring cracked</p> | <p>Replace casing lower part.</p> |

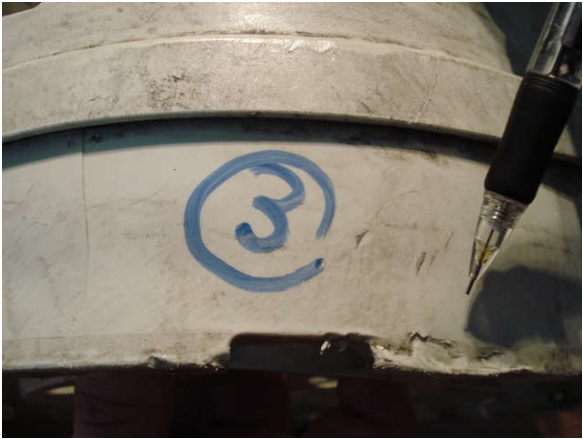
| | <p>Casing lower part foot-ring cracked</p> | <p>Replace casing lower part.</p> |

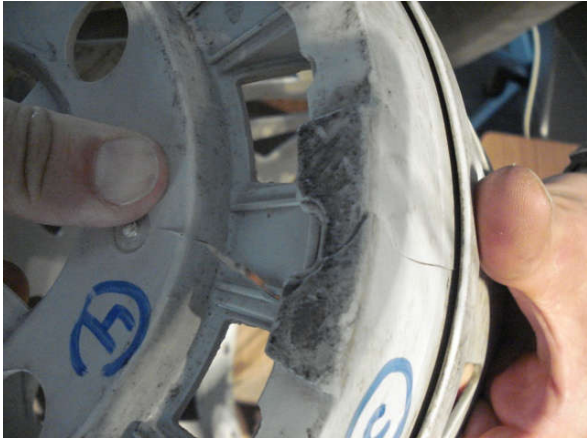
| | <p>Casing lower part foot-ring cracked</p> | <p>Replace casing lower part.</p> |

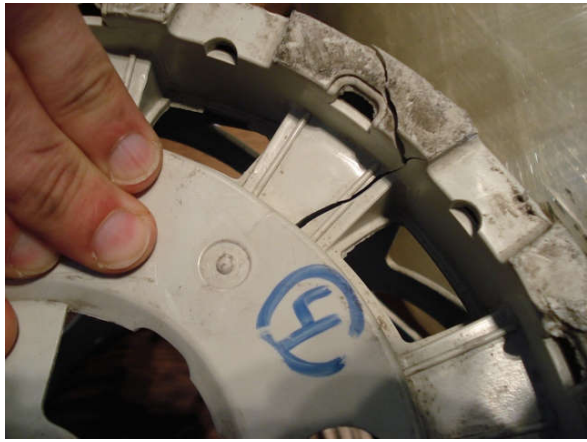
| | <p>Casing lower part foot-ring cracked</p> | <p>Replace casing lower part.</p> |

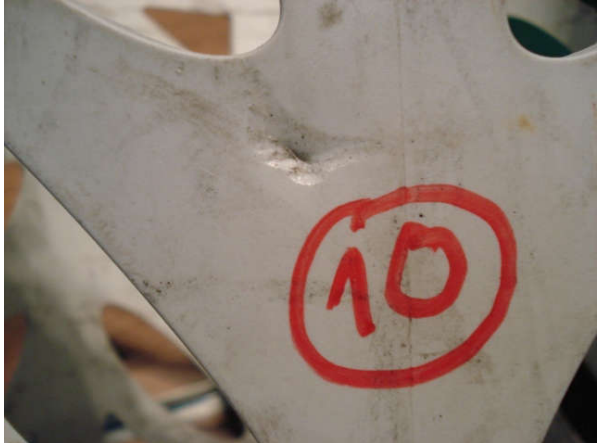
| | <p>Casing lower part cylindrical area damaged</p> | <p>Replace casing lower part.</p> |

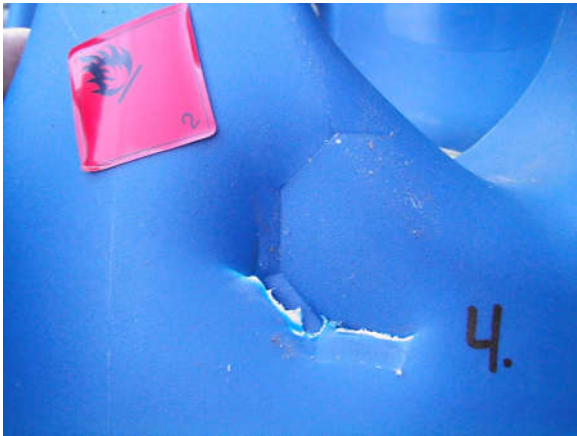
| | <p>Impact on handle part of casing</p> | <p>Replace casing lower part.</p> |

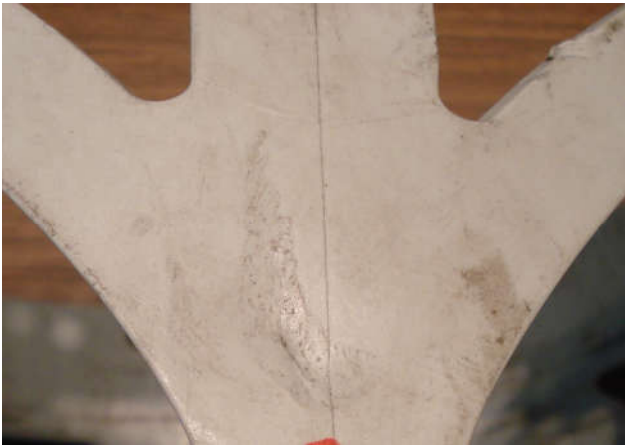
| | <p>Casing lower part cylindrical area damaged</p> | <p>Replace casing lower part.</p> |

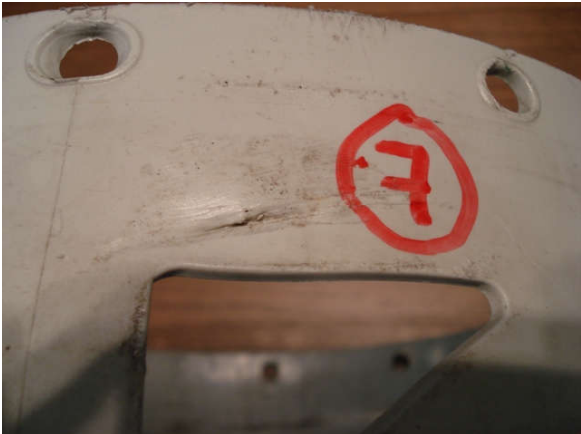
| | <p>Casing lower part<br/>cylindrical area damaged</p> | <p>Replace casing<br/>lower part.</p> |

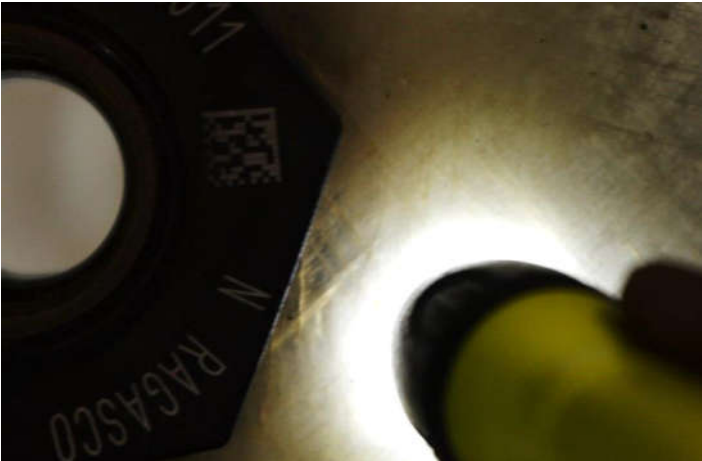
| | <p>Fiber broken under<br/>flange<br/>(Comment: Resin may<br/>be broken to this level<br/>with no relevant effect on<br/>safety)</p> <p><small>Photo courtesy of<br/>PrestaCylinders</small></p> | <p>Fiber broken<br/>(or in doubt)<br/>⇒<br/>Reject</p> <p>Only limited<br/>resin crack<br/>&lt;50mm = No<br/>action.</p> |

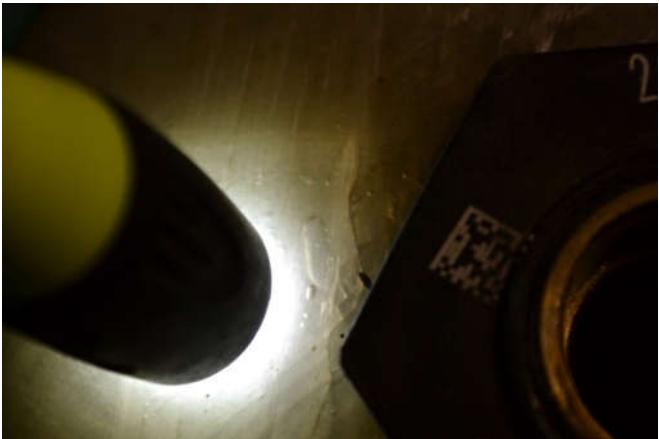
| | <p>Fiber broken under<br/>flange<br/>(Comment: Resin may<br/>be broken to this level<br/>with no relevant effect on<br/>safety)</p> <p><small>Photo courtesy of<br/>PrestaCylinders</small></p> | <p>Fiber broken<br/>(or in doubt)<br/>⇒<br/>Reject</p> <p>Only limited<br/>resin crack<br/>&lt;50mm = No<br/>action.</p> |

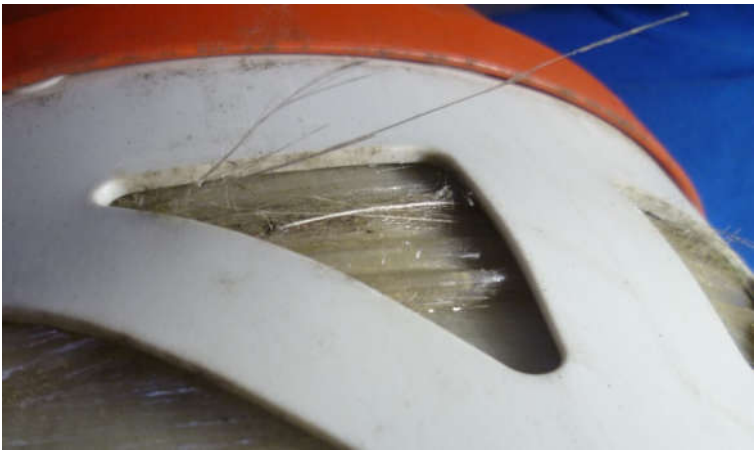
| | <p>Fiber peeled on vertical part<br/>(Comment: Not affecting cylinder behavior, Cutting the loose strand with a knife/scissors is recommended to avoid customers hurting themselves).</p> | <p>No action</p> |

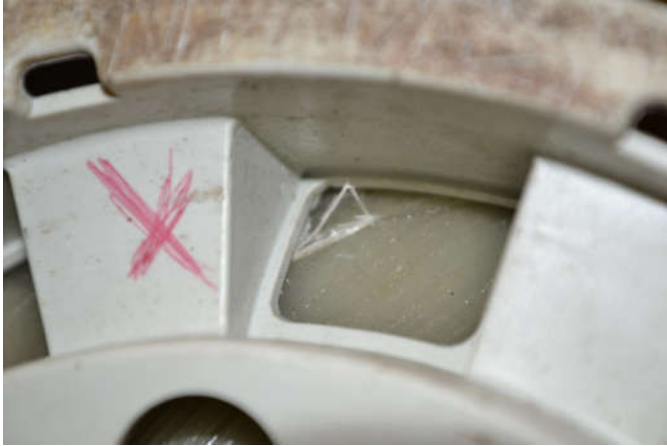
| | <p>Fiber broken under foot ring, not in combination with outer damage<br/>(Comment: an irregularity from production, not affecting safety. If in combination with signs of hard use or other damage, the cylinder shall be rejected)</p> | <p>No action</p> |

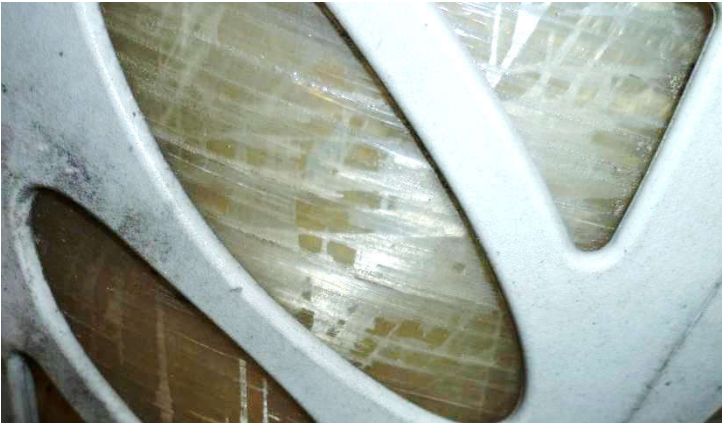
| | <p>Air to in the surface layer of composite, not into the lower layers.</p> <p><small>Photo courtesy of PrestaCylinders</small></p> | <p><i>Area less than 60mm x 60mm</i><br/>= No action.</p> |

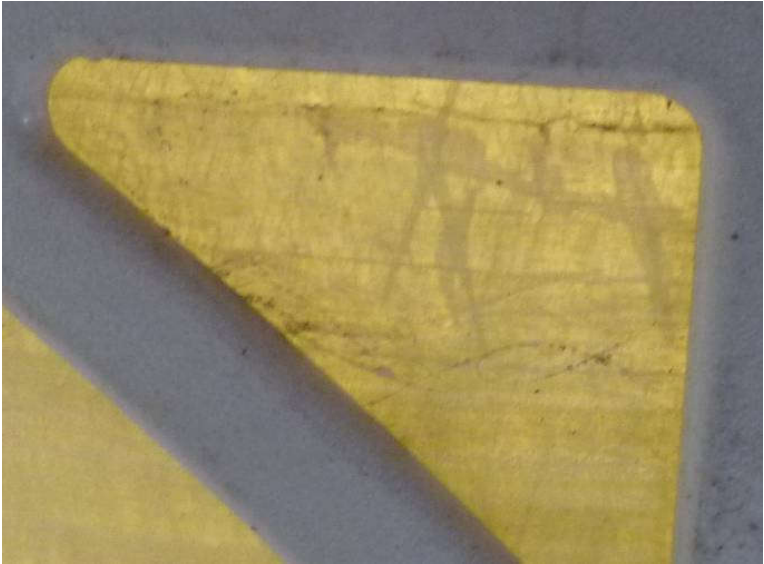
| | <p>Some delamination,<br/><br/>Not in combination with surface damage =&gt; no action.</p> <p><small>Photo courtesy of PrestaCylinders</small></p> | <p>No action</p> |

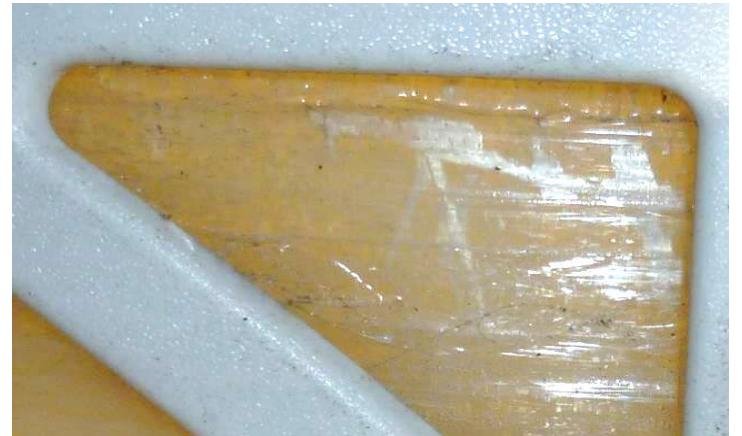
| | <p>Delamination, not in combination with signs of impact.</p> <p>Photo courtesy of PrestaCylinders</p> | <p>&lt; 30% surface of cylinder = OK.<br/>&gt;30% → reject</p> |

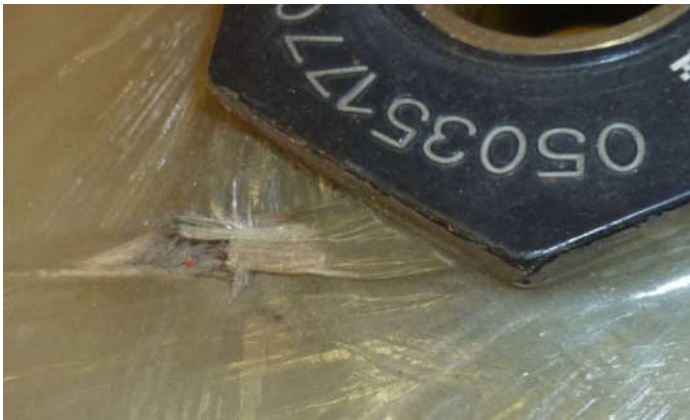
| | <p>Fiber broken</p> <p><small>Photo courtesy of PrestaCylinders</small></p> | <p>Reject</p> |

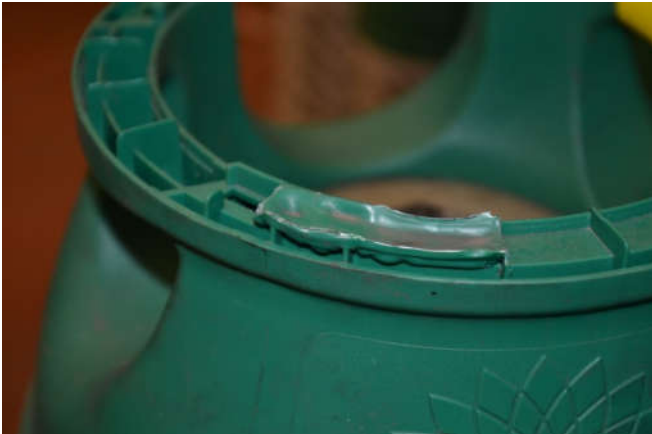
| | <p>Ring and possibly handle melted / burned, but not lower than 15 mm from the interface between ring and handle.</p> <p><small>Photo courtesy of PrestaCylinders</small></p> | <p>Replace ring and possibly handle</p> |

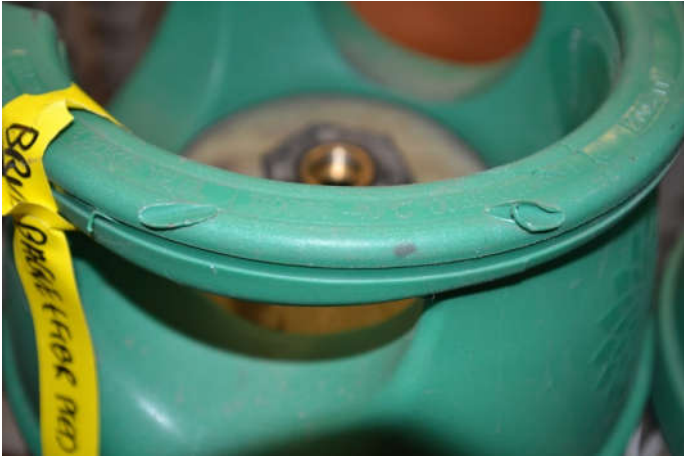
| | <p>Ring melted / burned<br/>(Comment: Actual picture is from G1, replacement is not possible – only on cylinders with mechanical snap).</p> <p><small>Photo courtesy of<br/>PrestaCylinders</small></p> | <p>Replace ring</p> |

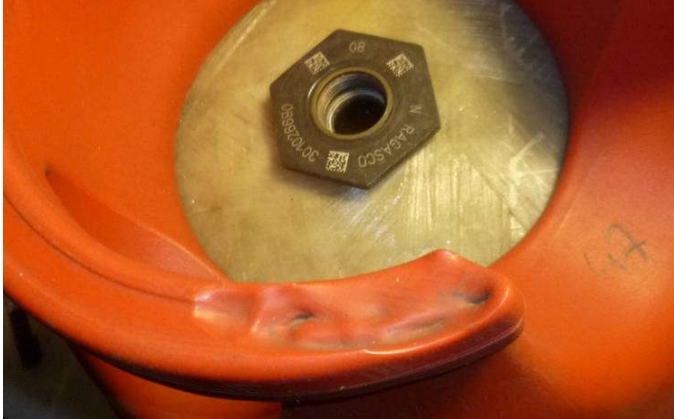
| | <p>Ring and possibly handle melted / burned, but not lower than 15 mm from the interface between ring and handle</p> <p><small>Photo courtesy of<br/>PrestaCylinders</small></p> | <p>Replace ring and possibly handle</p> |

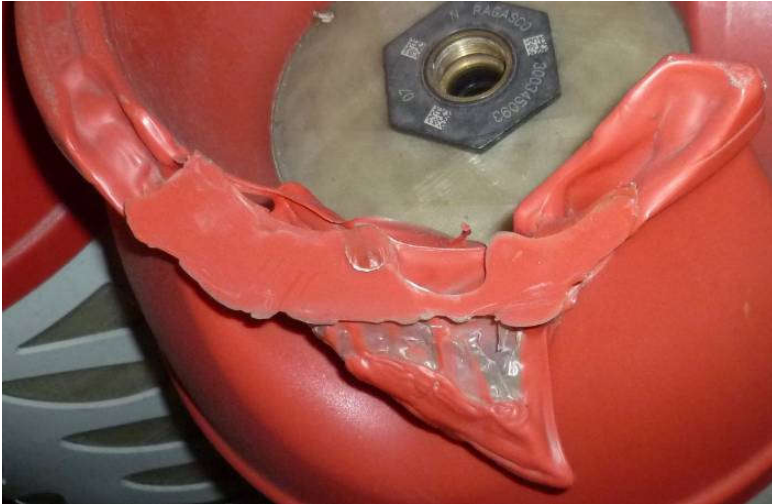
| | <p>Ring and handle melted / burned lower than 30 mm from the interface between ring and handle. No sign of heat to boss or composite.</p> <p><small>Photo courtesy of<br/>PrestaCylinders</small></p> | <p>Reject</p> |

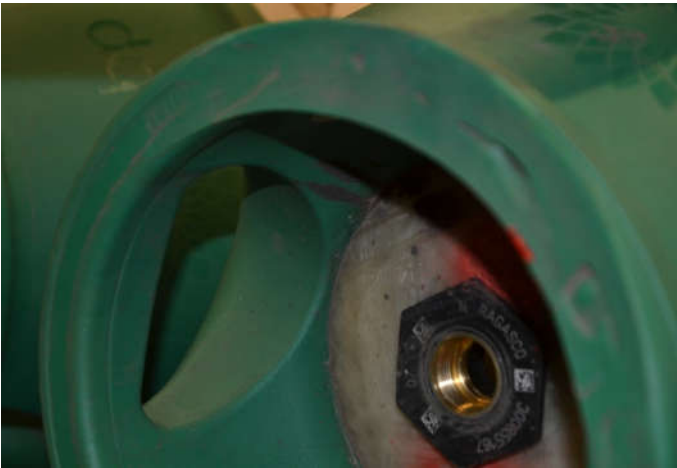
| | <p>Ring and handle part melted, no heat indication on boss or composite.</p> <p>Photo courtesy of PrestaCylinders</p> | <p>Replace ring and handle.</p> |

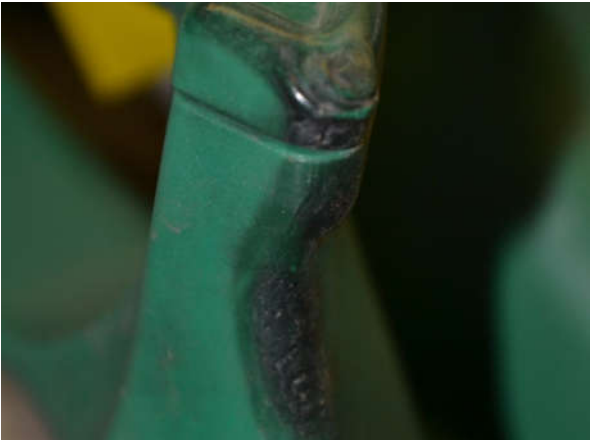
| <p>Photo courtesy of PrestaCylinders</p> | <p>Ring and handle melted / burned lower than 30 mm from the interface between ring and handle</p> <p>Photo courtesy of PrestaCylinders</p> | <p>Reject</p> |

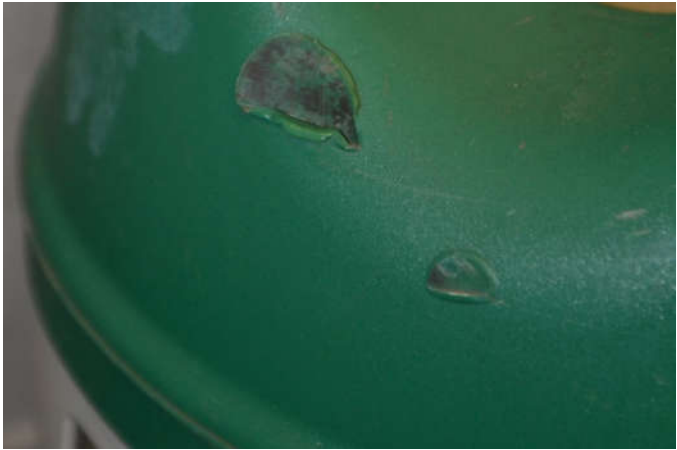
| <p>Photo courtesy of PrestaCylinders</p> | <p>Handle part of casing melted due direct exposure to hot object on small area. not close to snap/skirt, no marking damaged, no heat indication on boss or composite</p> <p>Photo courtesy of PrestaCylinders</p> | <p><i>Replace handle</i></p> |

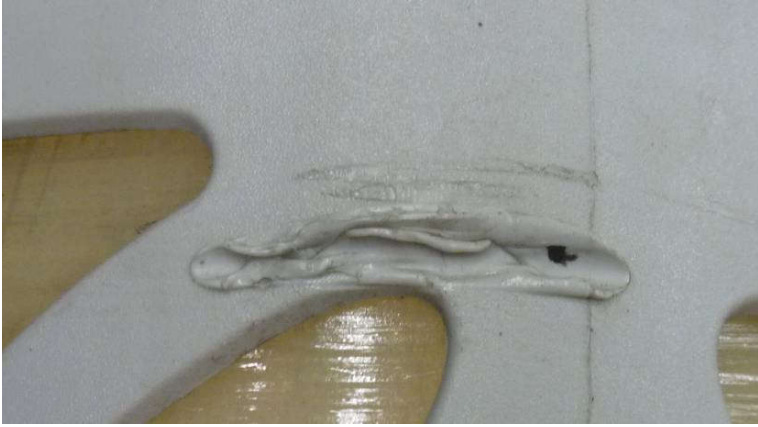
| | <p>Handle and casing lower part melted.</p> | <p>Reject.</p> |

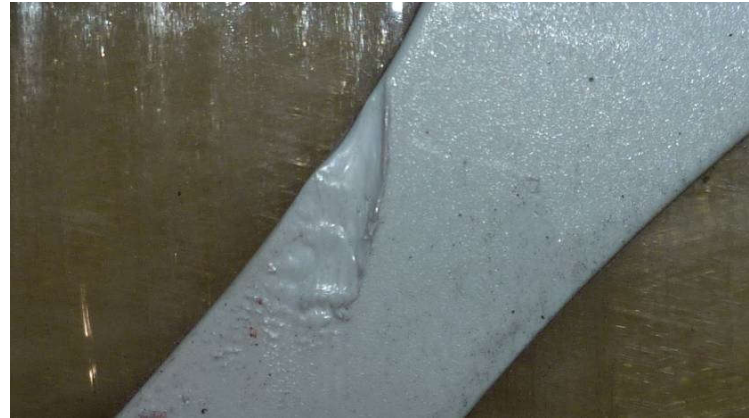
| | <p>Handle and casing lower part melted.</p> | <p>Reject.</p> |

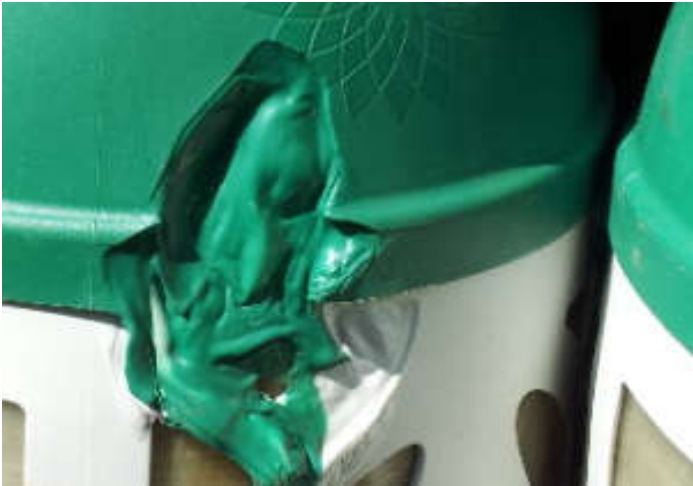
| | <p>Handle and casing lower part melted.</p> | <p>Reject.</p> |

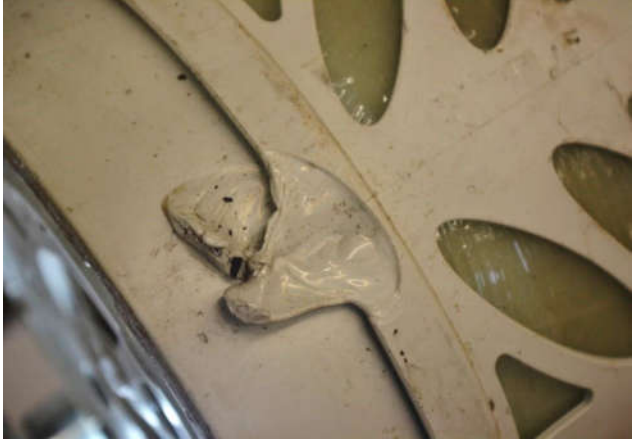
| | <p>Casing lower part melted.</p> <p><small>Photo courtesy of PrestaCylinders</small></p> | <p>Reject</p> |

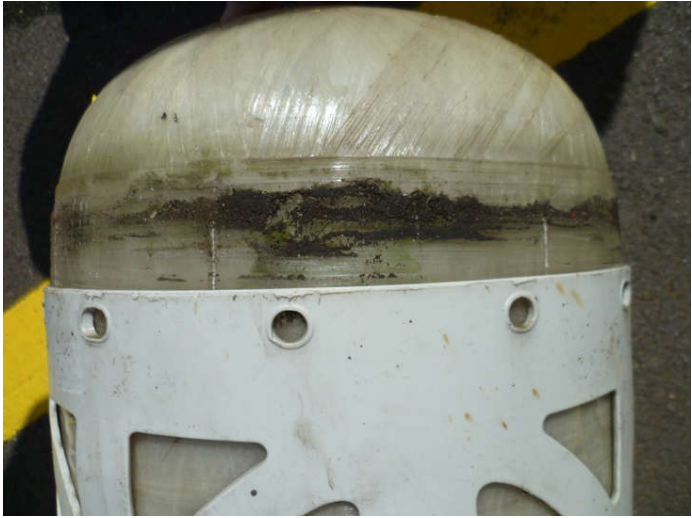
| | <p>Moisture between fiber and casing, no signs of chemical degeneration (no resin soft spots or significant discoloring)</p> | <p>No action</p> |

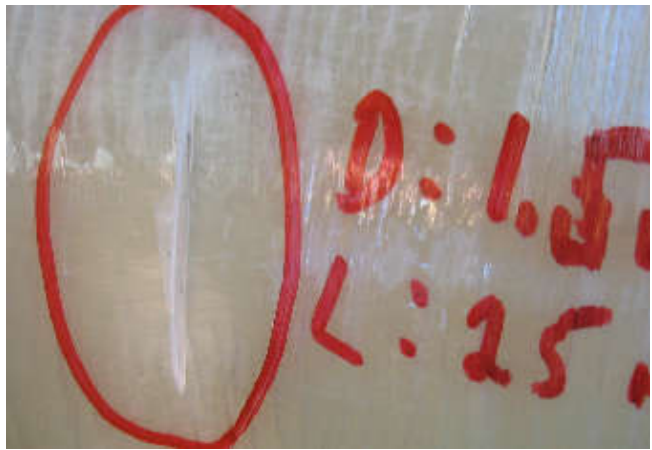
| | Cut fiber, more than one fibre tow.<br>(Comment: See table in section 7 for details and limits). | Reject |

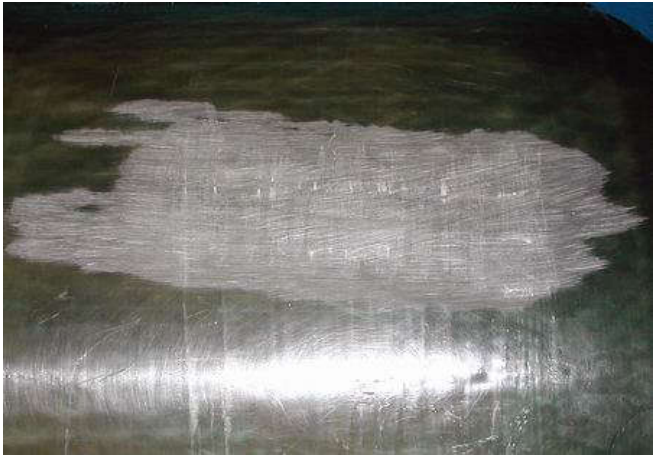
| | <p>Damage from abrasion<br/>(Comment: See table in section 7 for details and limits).</p> | <p>Reject</p> |

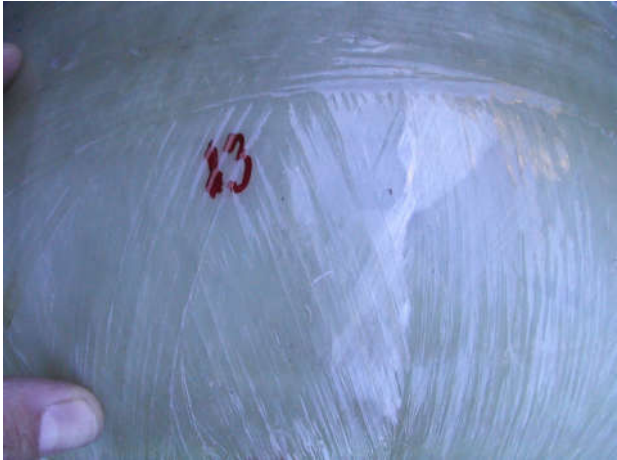
| | <p>Impact damage in combination with delamination and surface defects.</p> | <p>Reject</p> |

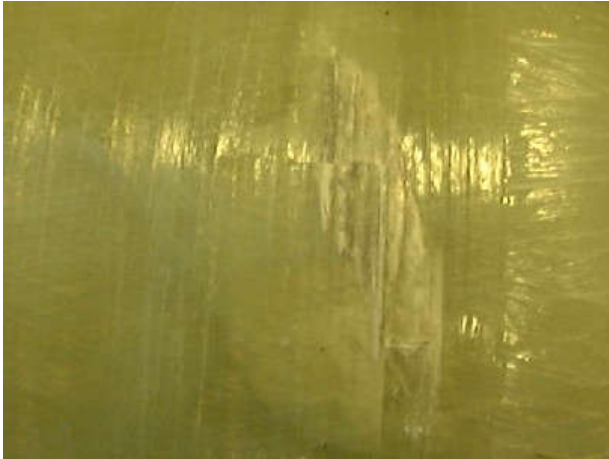
| | <p>Impact damage in combination with delamination and surface defects.</p> | <p>Reject</p> |

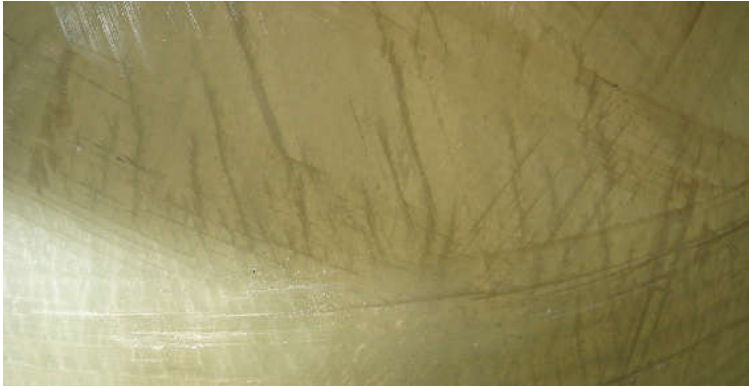
| | <p>Intra-laminar delamination due to pressure cycling &gt;12000 cycles to proof pressure.<br/>If less than approximately 100 hairlines, it is acceptable.</p> | <p>Reject</p> |

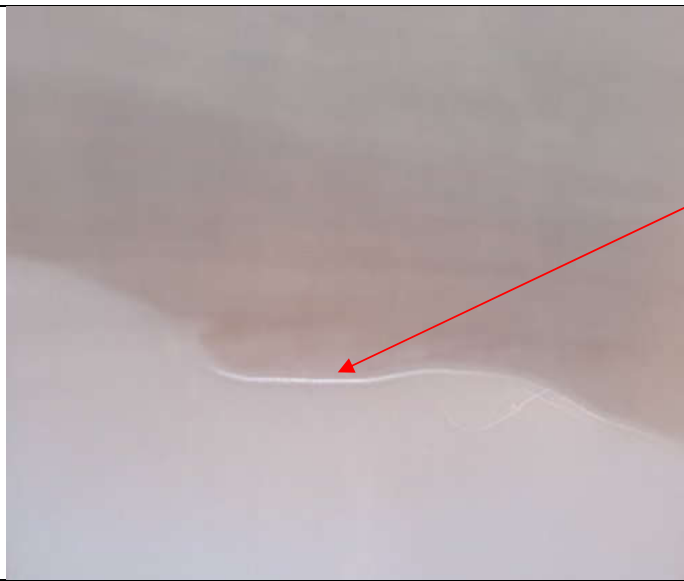
| | <p>Stretch-mark / white line in the liner at cylindrical / dome transition area (internal inspection). Usually in combination with partial lack of adhesion between liner and composite wrapping.</p> | <p>Reject</p> |

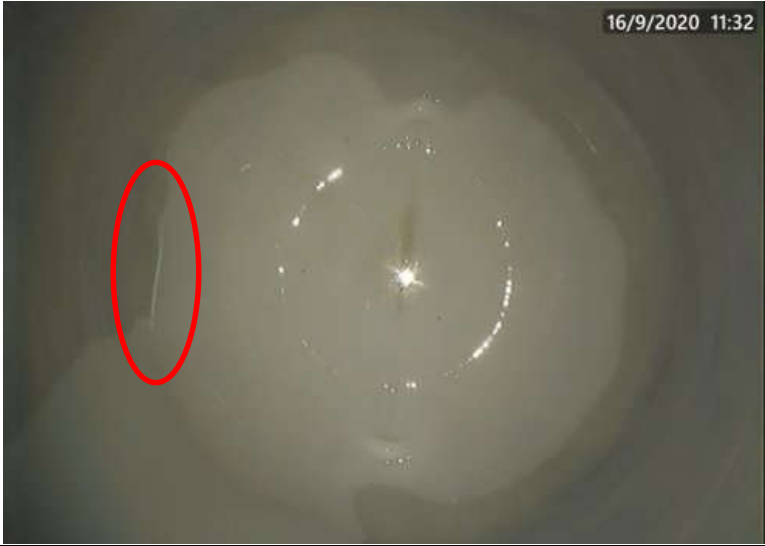
| | <p>Stretch-mark / white line in the liner at cylindrical / dome transition area (internal inspection). Usually in combination with partial lack of adhesion between liner and composite wrapping (whitish area in the picture).</p> | <p>Reject</p> |

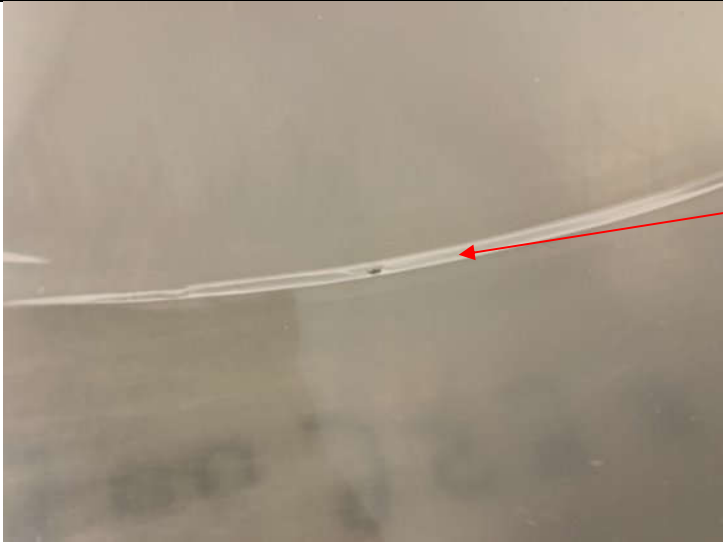
| | <p>Crack in the liner at cylindrical / dome transition area (internal inspection).</p> | <p>Reject</p> |
