Ragasco Composite Propane Cylinders

# Appendix 1 - Criteria for Cylinder Inspection

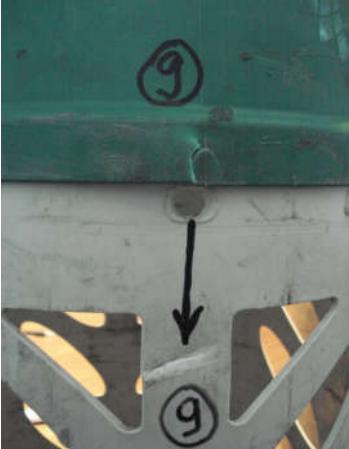
<p><b>Damage on handle “skirt”, and lower part</b></p>	<p><b>Replace handle and casing lower part.</b></p>

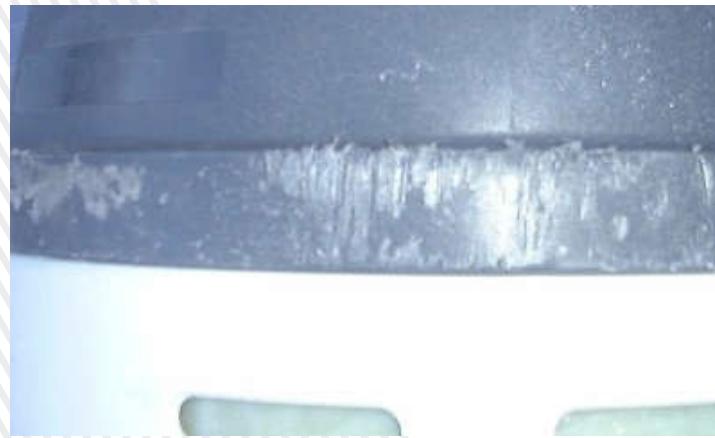
<p><b>Damage on handle “skirt”, and potentially casing lower part.</b></p>	<p><b>Replace handle and potentially casing lower part.</b></p>

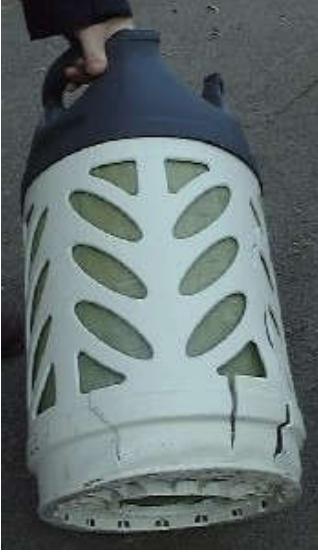
<p><b>Damage on casing lower part.</b></p>	<p><b>Replace casing lower part.</b></p>

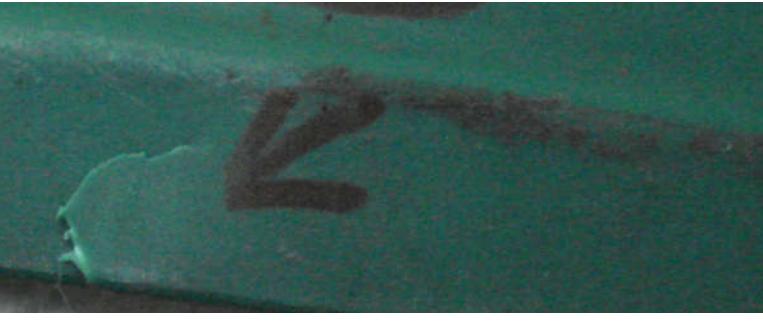
<p><b>Damage on handle "skirt", typically beside the snap</b></p>	<p><b>Replace handle</b></p>

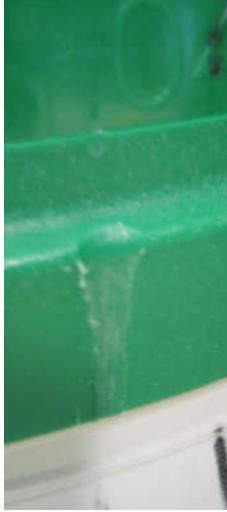
<p><b>Damage on handle "skirt" and potentially casing lower part.</b></p>	<p><b>Replace handle and potentially casing lower part.</b></p>

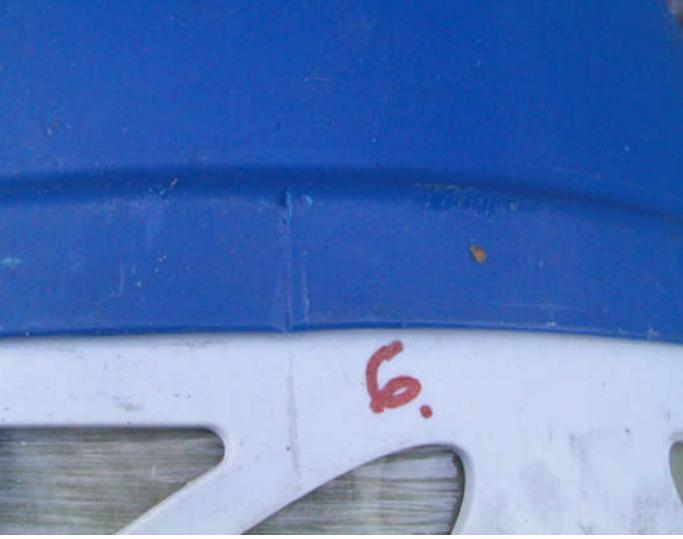
<p><b>Damage on handle "skirt" and casing lower part.</b></p>	<p><b>Replace handle and casing lower part.</b></p>

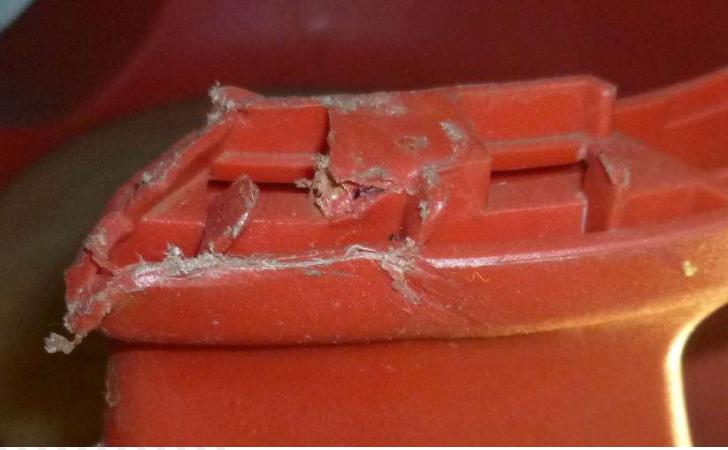
<p><b>Ring and handle part broken → impossible to replace ring</b></p>	<p><b>Replace ring and handle</b></p>

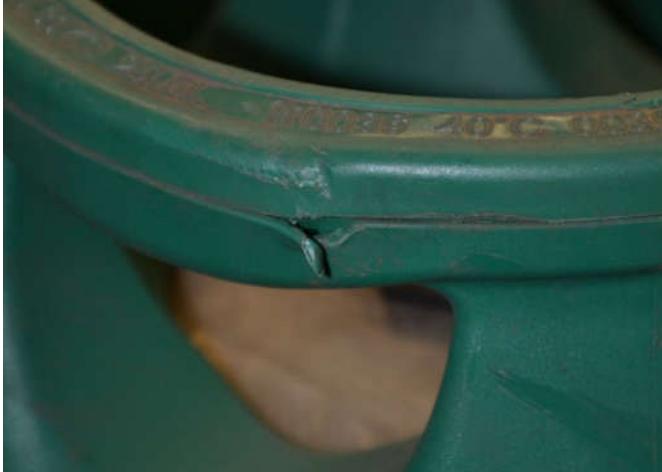
<p><b>Crack on ring and handle part. Potentially rough handling.</b></p> <p><small>Photo courtesy of PrestaCylinders</small></p>	<p><b>Replace ring and handle.</b></p>

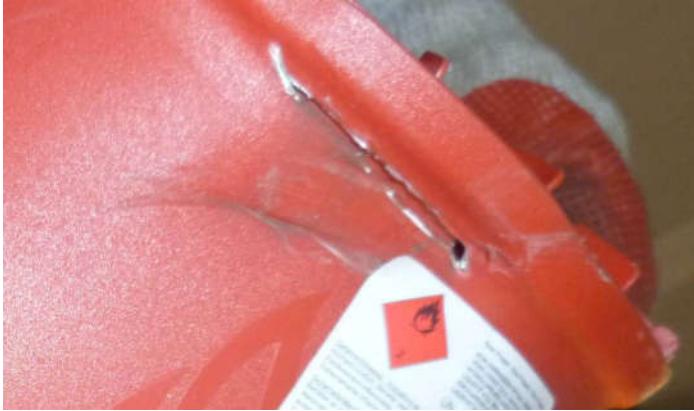
<p><b>Ring and handle damaged</b></p> <p><small>Photo courtesy of PrestaCylinders</small></p>	<p><b>Replace ring and handle</b></p>

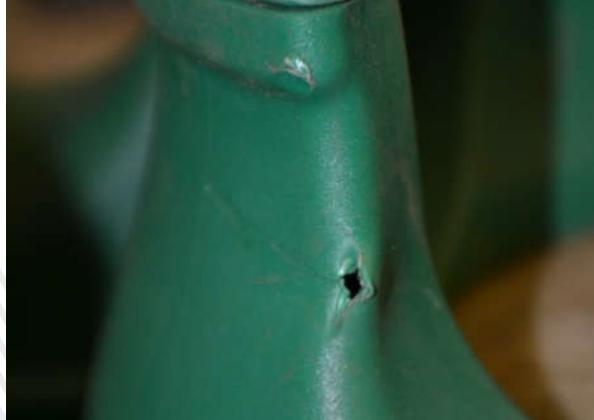
<p><b>Impact on handle part of casing</b></p> <p><small>Photo courtesy of PrestaCylinders</small></p>	<p><b>Replace handle</b></p>

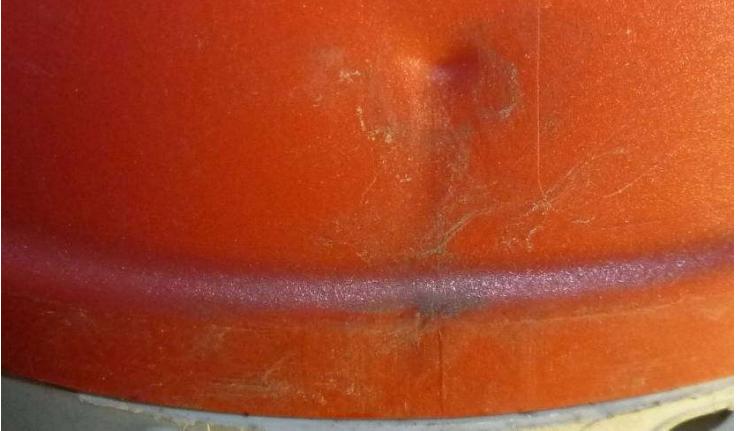
<p><b>Impact on handle part and potentially casing lower part</b></p> <p>Photo courtesy of <a href="#">PrestaCylinders</a></p>	<p><b>Replace handle and casing lower part</b></p>

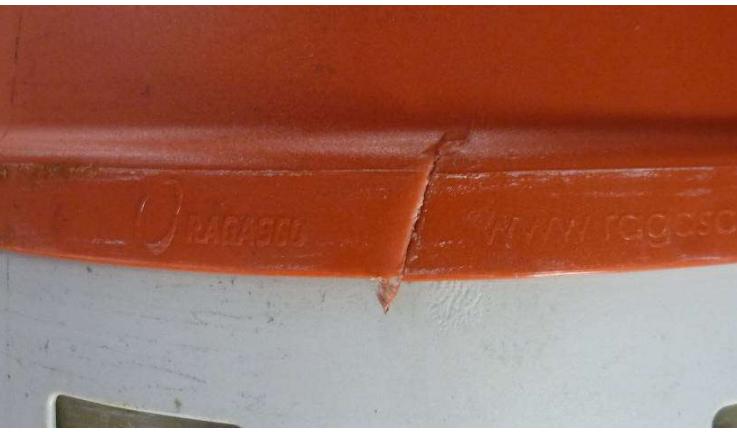
<p><b>Impact on handle part and potentially casing lower part</b></p> <p>Photo courtesy of <a href="#">PrestaCylinders</a></p>	<p><b>Replace handle and casing lower part</b></p>

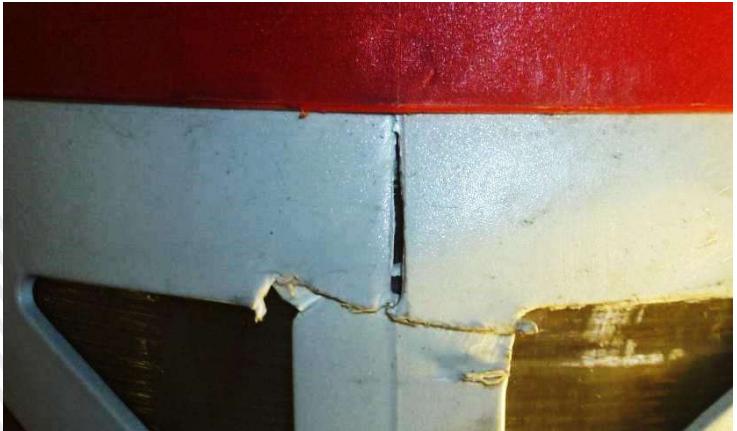
<p><b>Composite damaged due to impact or abrasion. Casing lower part broken, potentially also snap on handle part.</b></p> <p>Photo courtesy of <a href="#">PrestaCylinders</a></p>	<p><b>Reject.</b></p>

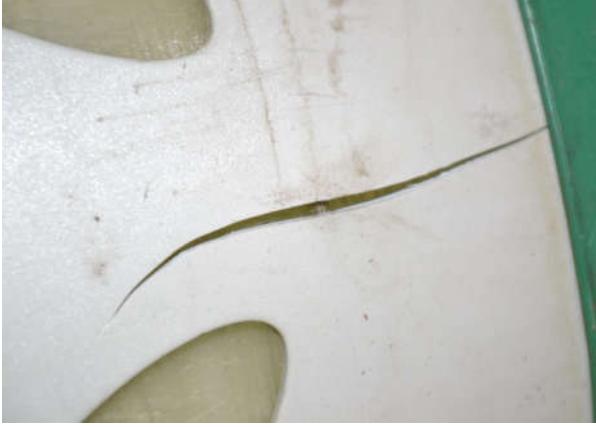
<p><b>Casing lower part broken because of composite uneven surface.</b></p> <p><small>Photo courtesy of PrestaCylinders</small></p>	<p>No action</p>

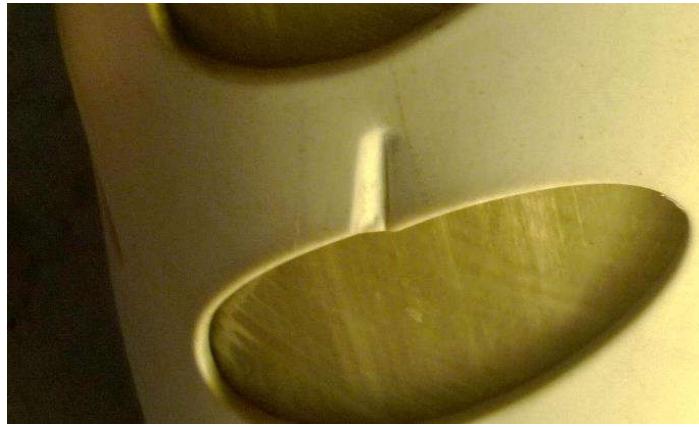
<p><b>Damage to casing lower part. No visual impact on fibre.</b></p> <p><small>Photo courtesy of PrestaCylinders</small></p>	<p>Replace casing lower part.</p>

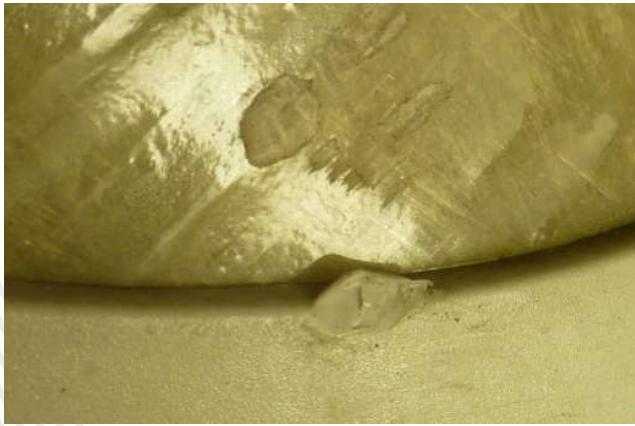
<p><b>Damage to fibre and casing lower part.</b></p> <p><small>Photo courtesy of PrestaCylinders</small></p>	<p>Reject</p>

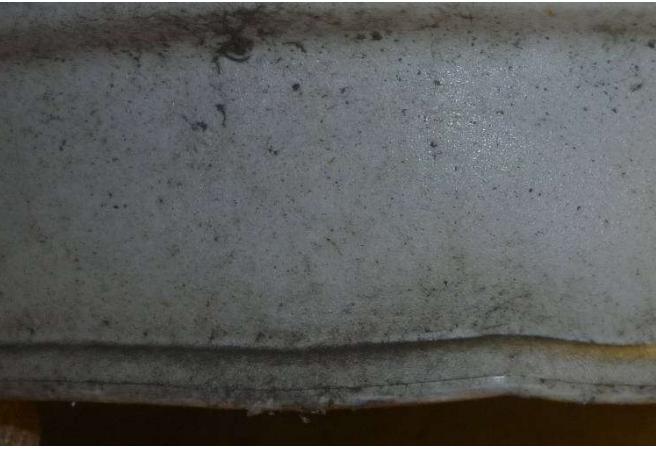
<p><b>Casing lower part broken without any sign of impact</b></p> <p><small>Photo courtesy of PrestaCylinders</small></p>	<b>No action</b>

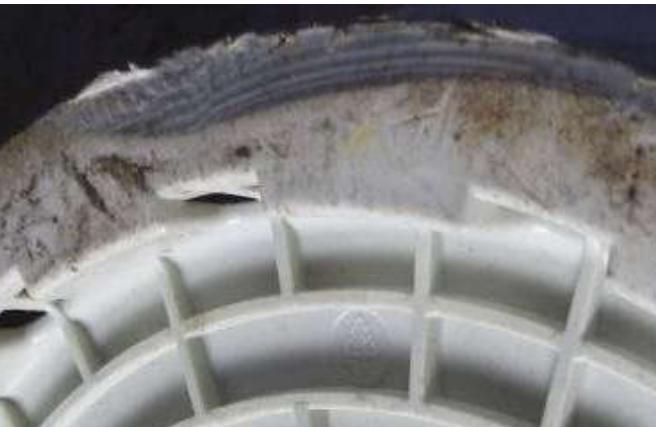
<p><b>Casing lower part foot-ring deformed (no cracks in the bottom area casing or composite detected)</b></p> <p><small>Photo courtesy of PrestaCylinders</small></p>	<b>No action</b>
	<p><b>Casing lower part foot-ring deformed (no cracks in the bottom area casing or composite detected)</b></p> <p><small>Photo courtesy of PrestaCylinders</small></p>	<b>No action</b>

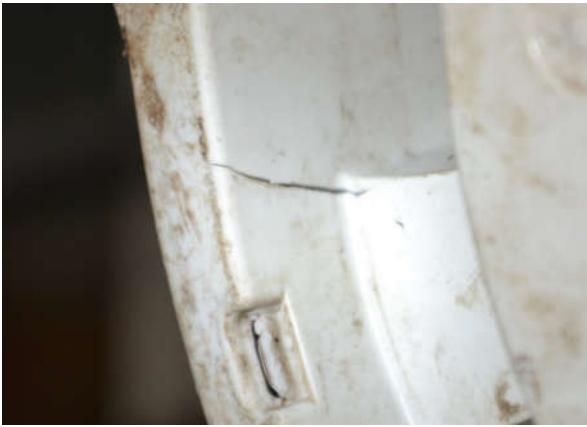
<p><b>Casing lower part foot-ring cracked</b></p>	<p><b>Replace casing lower part.</b></p>

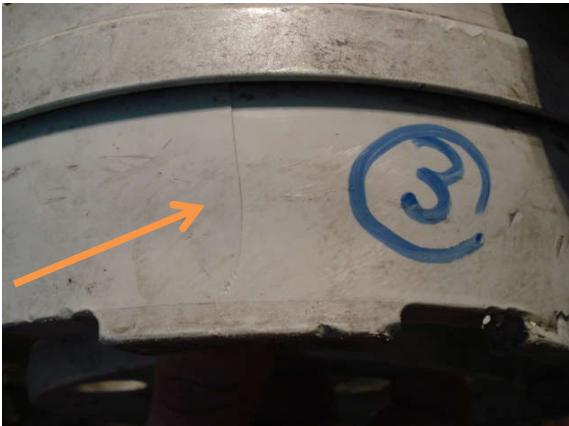
<p><b>Casing lower part foot-ring cracked</b></p>	<p><b>Replace casing lower part.</b></p>

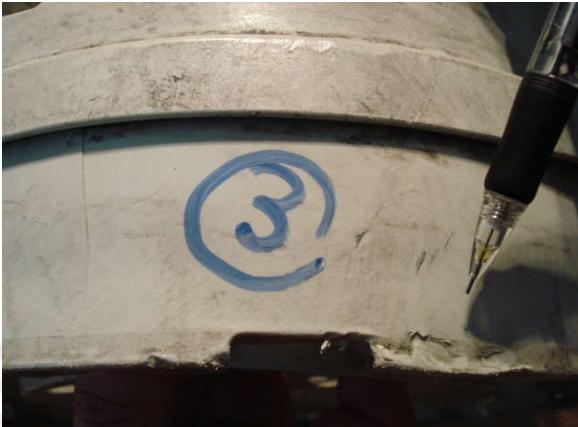
<p><b>Casing lower part foot-ring cracked</b></p>	<p><b>Replace casing lower part.</b></p>

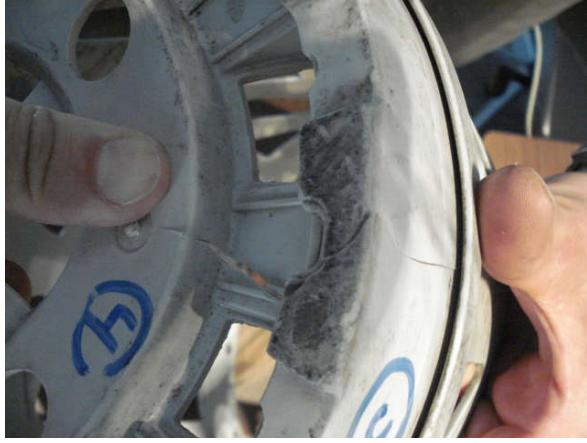
<p><b>Casing lower part foot-ring cracked</b></p>	<p><b>Replace casing lower part.</b></p>

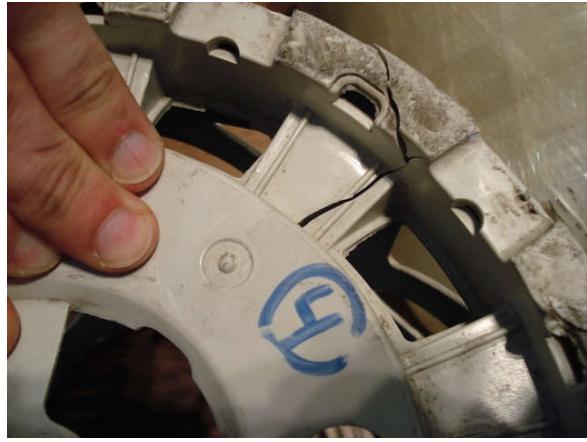
<p><b>Casing lower part foot-ring cracked</b></p>	<p><b>Replace casing lower part.</b></p>

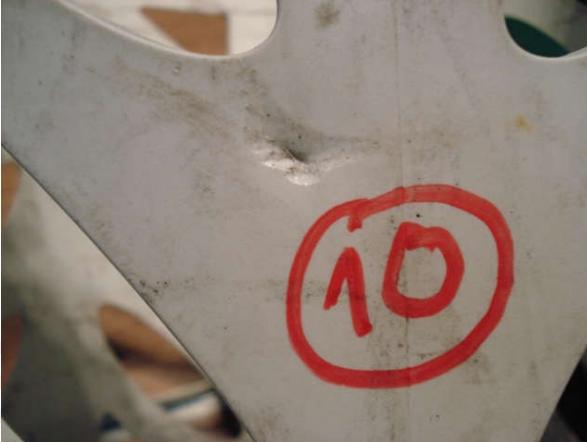
<p><b>Casing lower part cylindrical area damaged</b></p>	<p><b>Replace casing lower part.</b></p>

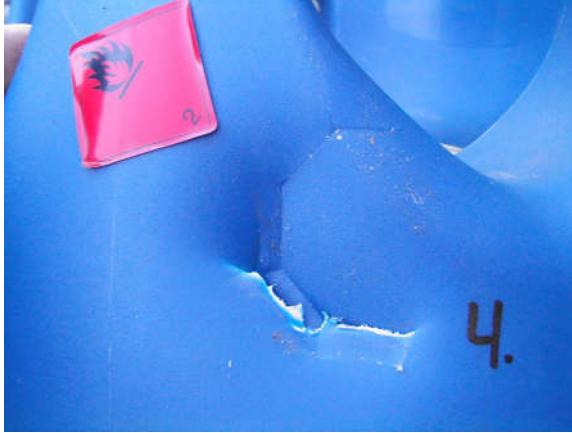
<b>Impact on handle part of casing</b>	<b>Replace casing lower part.</b>

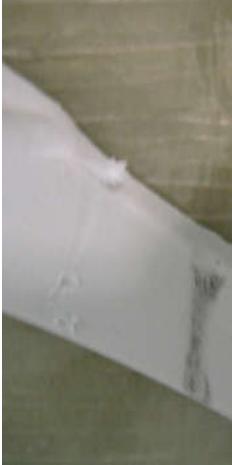
<b>Casing lower part cylindrical area damaged</b>	<b>Replace casing lower part.</b>

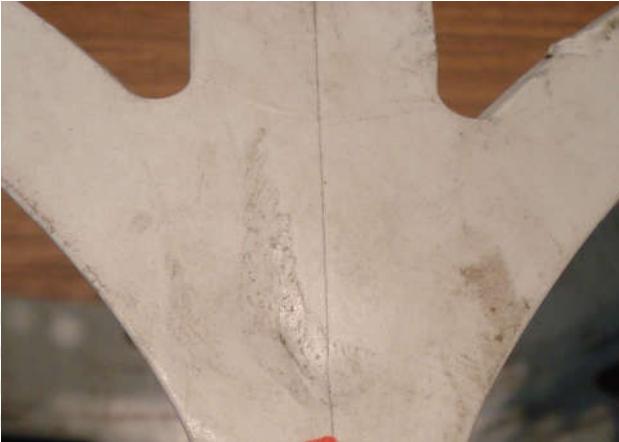
<b>Casing lower part cylindrical area damaged</b>	<b>Replace casing lower part.</b>

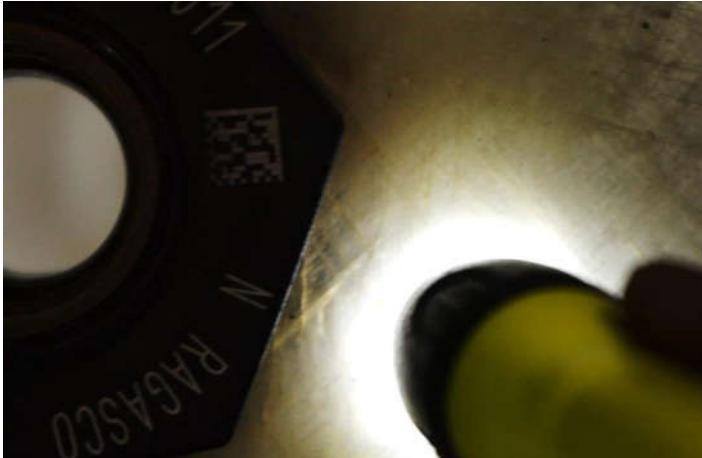
<p><b>Fiber broken under flange</b> (Comment: Resin may be broken to this level with no relevant effect on safety)</p> <p><small>Photo courtesy of PrestaCylinders</small></p>	<p><b>Fiber broken (or in doubt)</b> → Reject</p> <p>Only limited resin crack &lt;50mm = No action.</p>

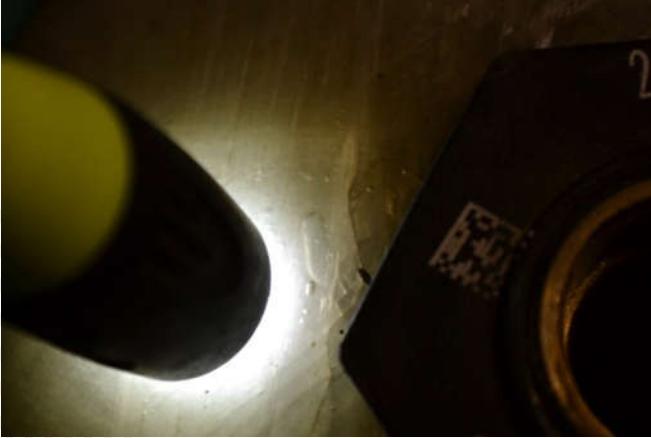
<p><b>Fiber broken under flange</b> (Comment: Resin may be broken to this level with no relevant effect on safety)</p> <p><small>Photo courtesy of PrestaCylinders</small></p>	<p><b>Fiber broken (or in doubt)</b> → Reject</p> <p>Only limited resin crack &lt;50mm = No action.</p>

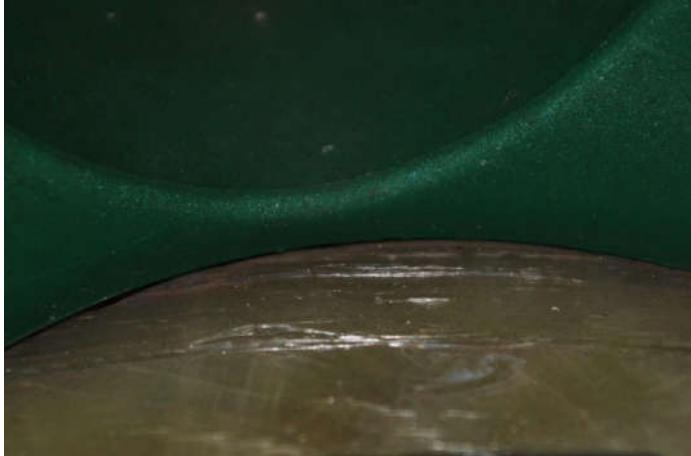
<p><b>Fiber peeled on top</b></p>	<p><b>No action</b></p>

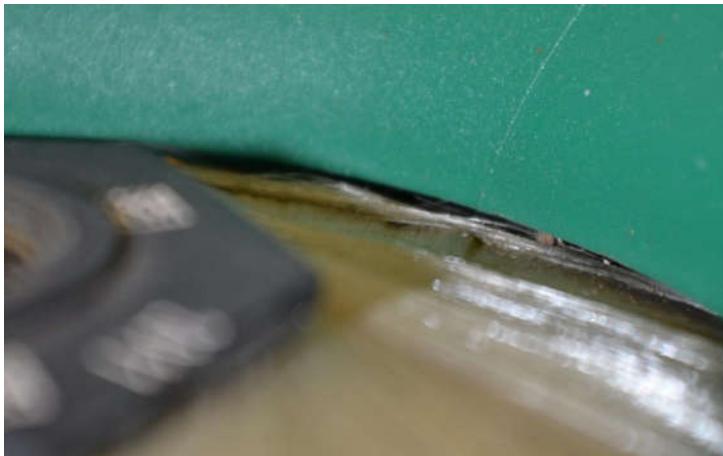
<p><b>Fiber peeled under plastic top part</b></p>	<p><b>No action</b></p>

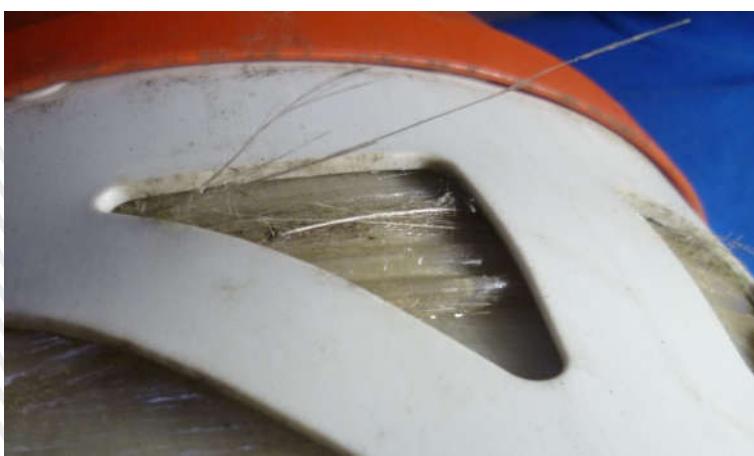
<p><b>Fiber peeled on vertical part (Comment: Not affecting cylinder behavior, Cutting the loose strand with a knife/scissors is recommended to avoid customers hurting themselves).</b></p>	<p><b>No action</b></p>

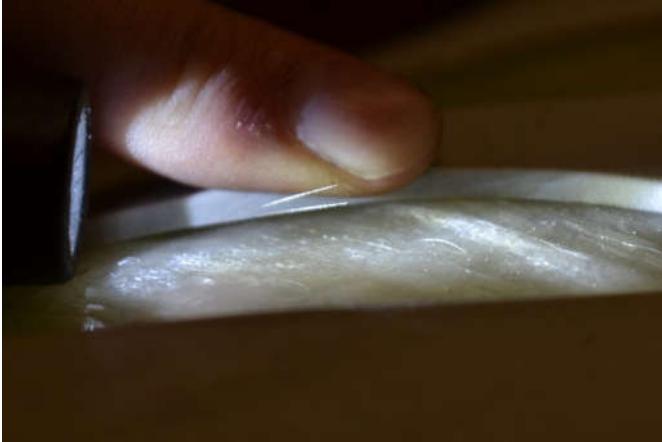
<p><b>Fiber peeled on vertical part</b></p>	<p>No action</p>

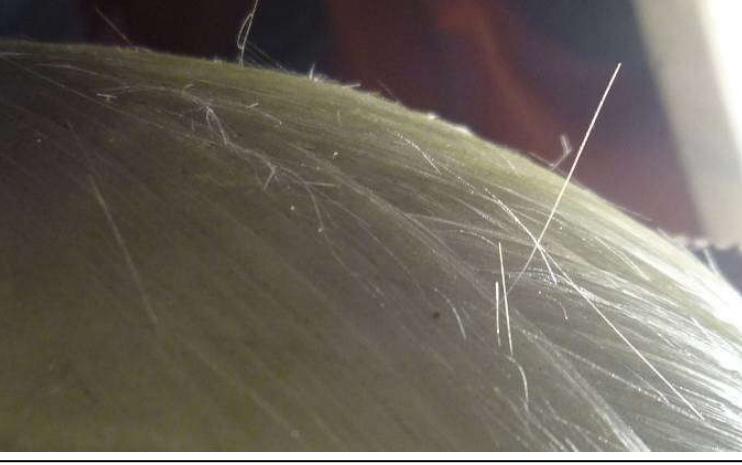
<p><b>Fiber peeled on vertical part</b></p> <p><small>Photo courtesy of PrestaCylinders</small></p>	<p>No action</p>

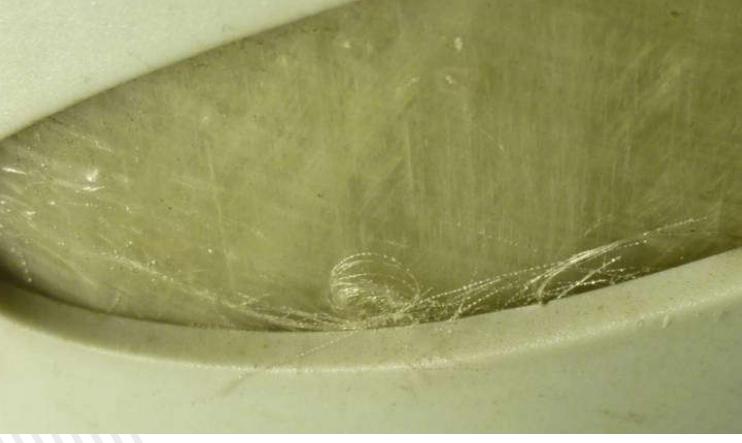
<p><b>Fiber peeled on vertical part</b></p> <p><small>Photo courtesy of PrestaCylinders</small></p>	<p>No action</p>

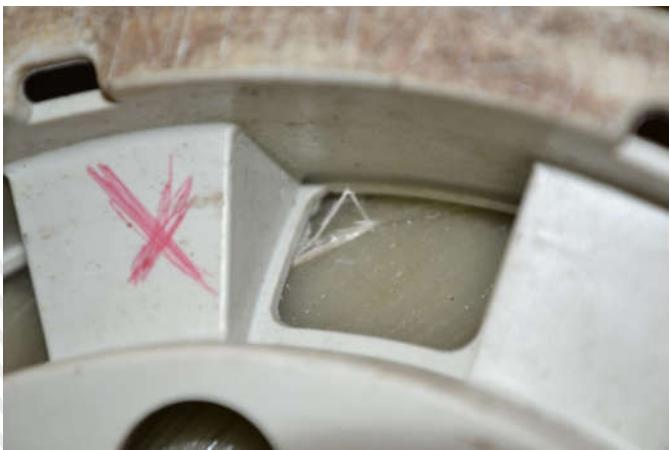
<p><b>Fiber broken under foot ring, not in combination with outer damage (Comment: an irregularity from production, not affecting safety. If in combination with signs of hard use or other damage, the cylinder shall be rejected)</b></p> <p><small>Photo courtesy of PrestaCylinders</small></p>	<b>No action</b>

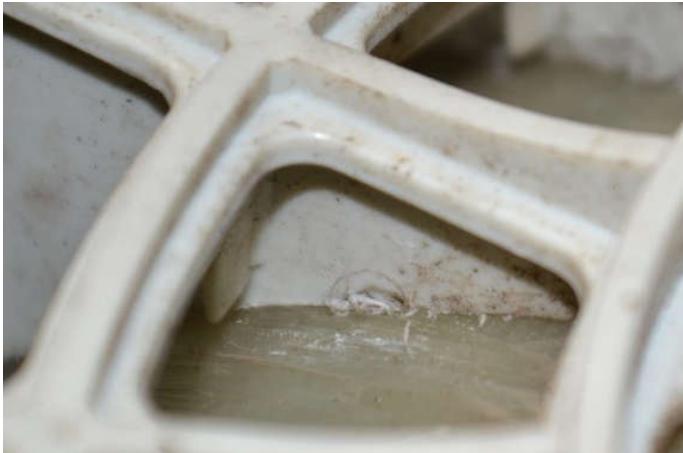
<p><b>Fiber scratched under foot ring</b></p>	<p><b>No action</b></p>

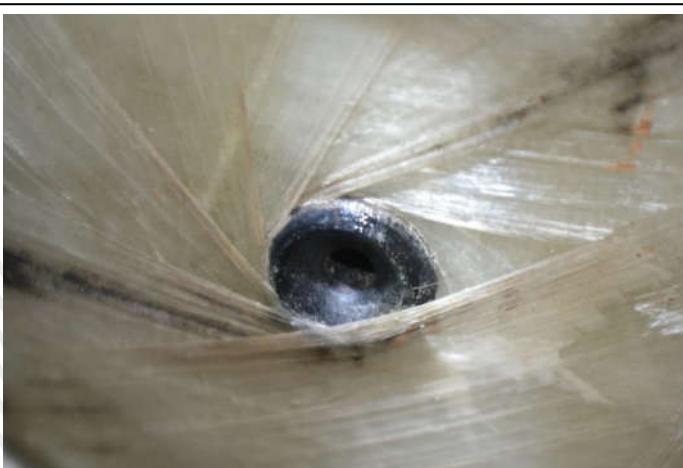
<p><b>Fiber dried and brittle on centering piece</b></p>	<p><b>No action</b></p>

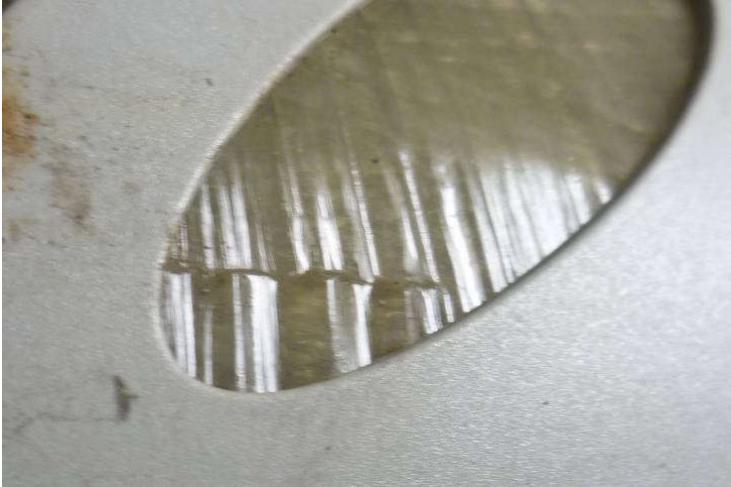
<p><b>Small edge from “fiber stop / end” during manufacturing</b></p> <p><small>Photo courtesy of PrestaCylinders</small></p>	<b>No action</b>

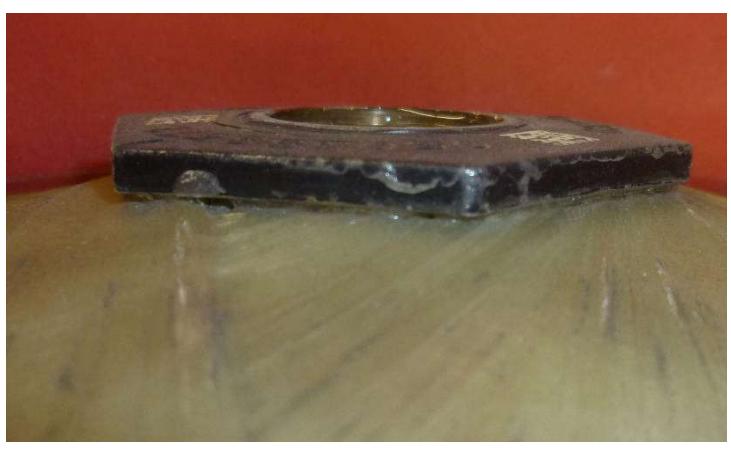
<p><b>Hexagonal flange touching composite (normal)</b></p> <p><small>Photo courtesy of PrestaCylinders</small></p>	<b>No action</b>

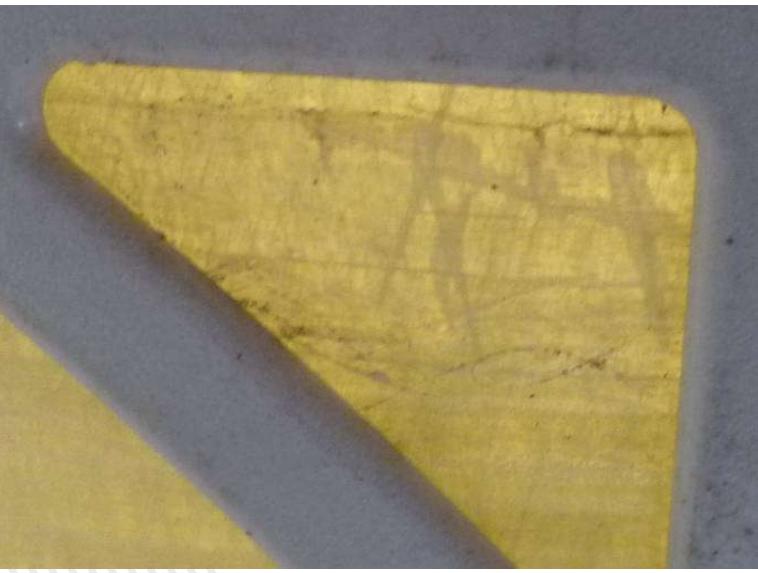
<p><b>Some delamination, Not in combination with surface damage =&gt; no action.</b></p>	<p>No action</p>

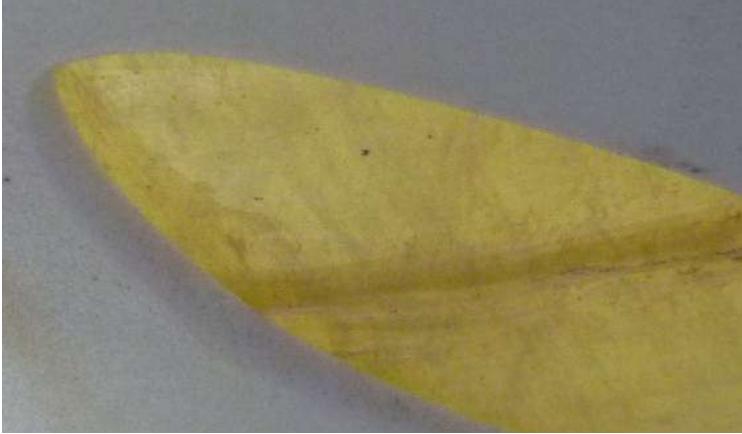
<p><b>Fiber tow standing somewhat out</b></p>	<b>No action</b>

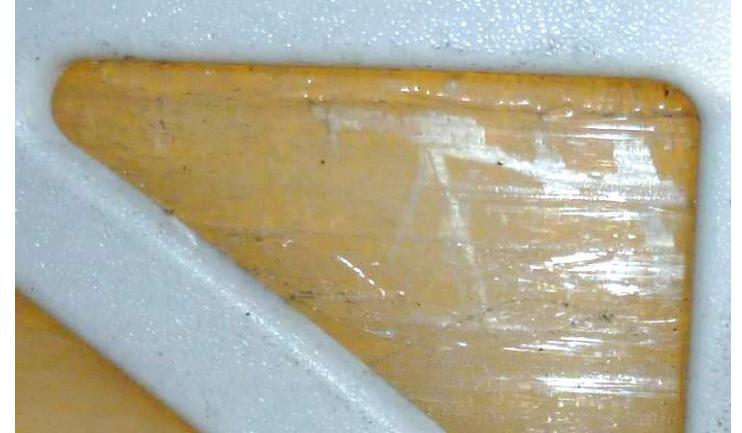
<p><b>Delamination, not in combination with signs of impact.</b></p> <p>&lt; 30% surface of cylinder = OK.</p> <p>&gt;30% → reject</p>

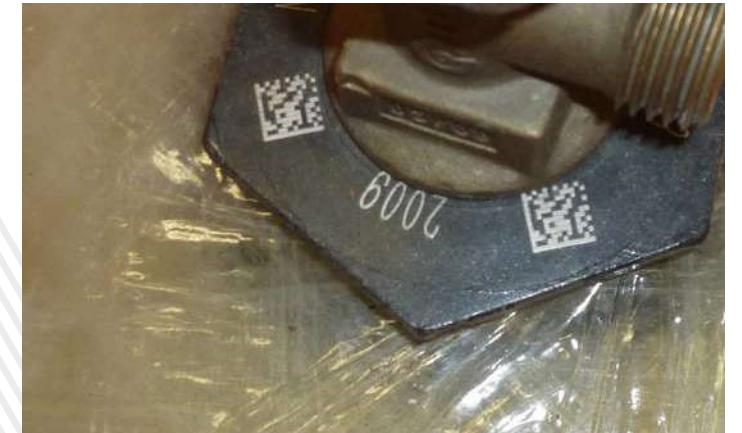
<p><b>Excess thickness of resin (normal).</b></p>	<b>No action</b>

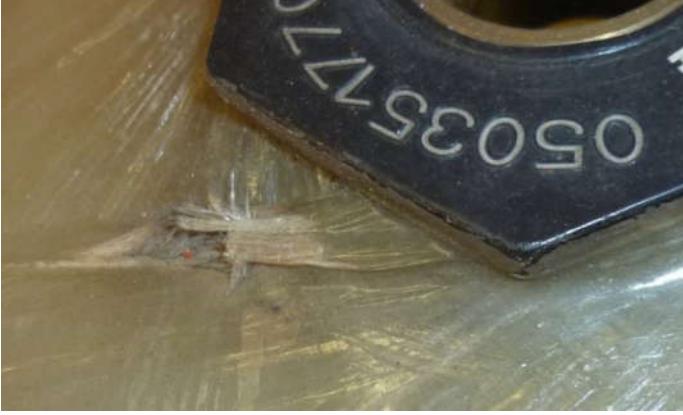
<p><b>Fiber broken</b></p>	<p><b>Reject</b></p>

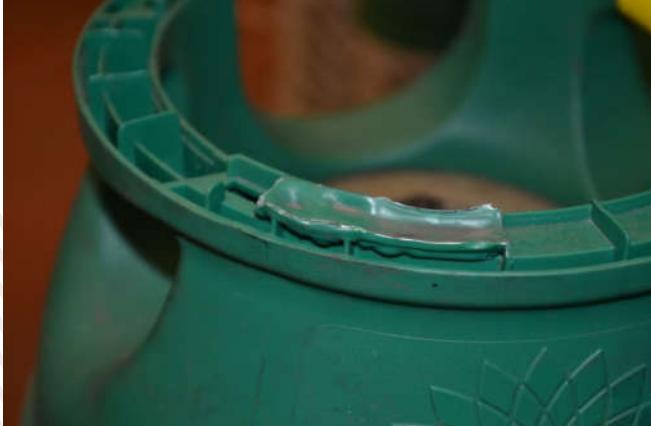
<p><b>Ring and possibly handle melted / burned, but not lower than 15 mm from the interface between ring and handle.</b></p> <p><small>Photo courtesy of PrestaCylinders</small></p>	<p>Replace ring and possibly handle</p>

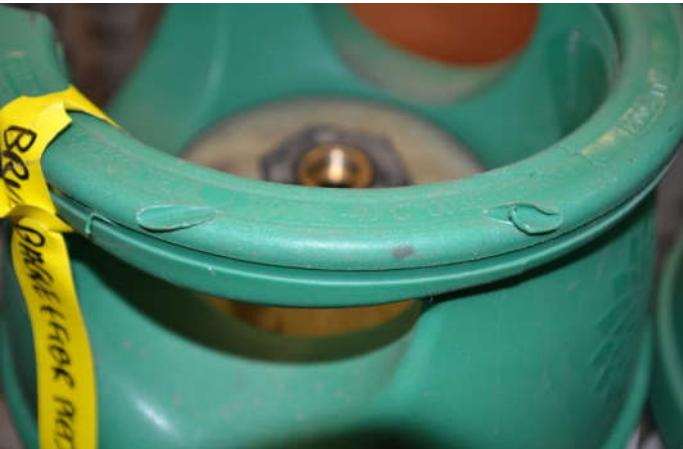
<p><b>Ring melted / burned</b>  <b>(Comment: Actual picture is from G1, replacement is not possible – only on cylinders with mechanical snap).</b></p> <p><small>Photo courtesy of PrestaCylinders</small></p>	<p><b>Replace ring</b></p>

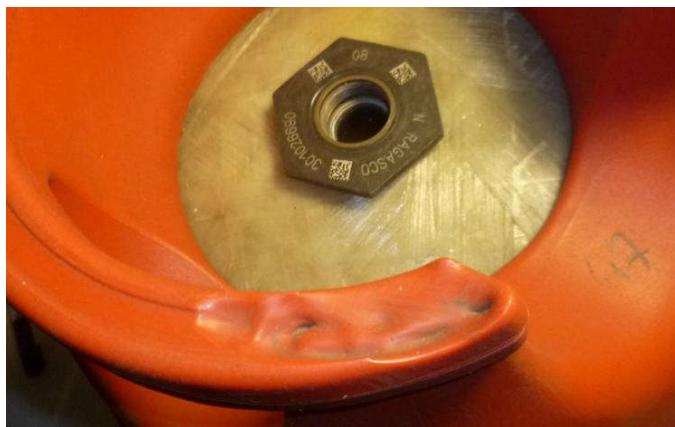
<p><b>Ring and possibly handle melted / burned, but not lower than 15 mm from the interface between ring and handle</b></p> <p><small>Photo courtesy of PrestaCylinders</small></p>	<p><b>Replace ring and possibly handle</b></p>

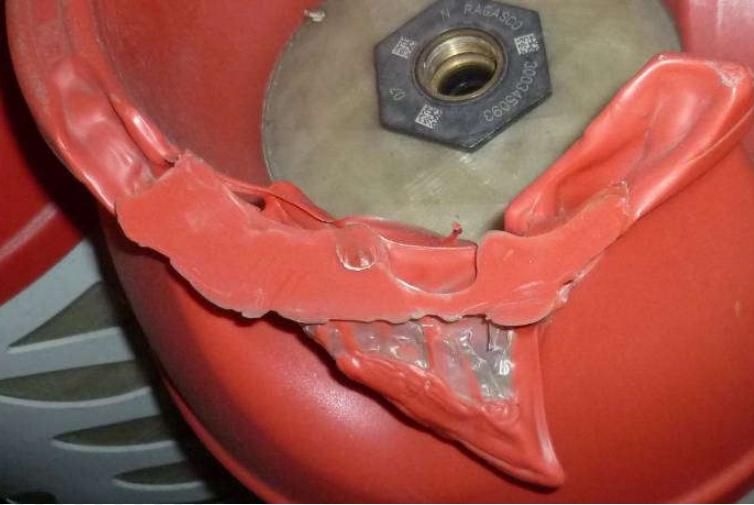
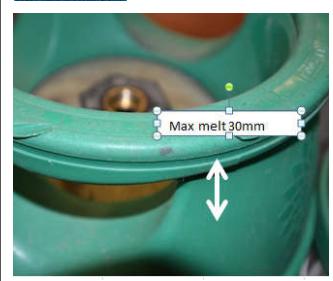
<p><b>Ring and handle melted / burned lower than 30 mm from the interface between ring and handle. No sign of heat to boss or composite.</b></p> <p><small>Photo courtesy of PrestaCylinders</small></p>

<p><b>Reject</b></p>

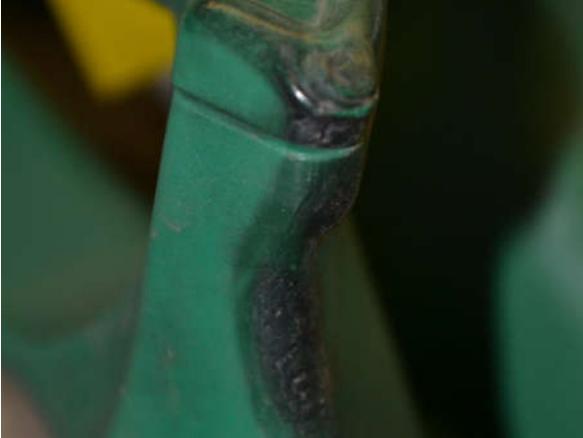
<p><b>Ring and handle melted / burned lower than 30 mm from the interface between ring and handle</b></p>

<p>Photo courtesy of PrestaCylinders</p>	<p><b>Reject</b></p>

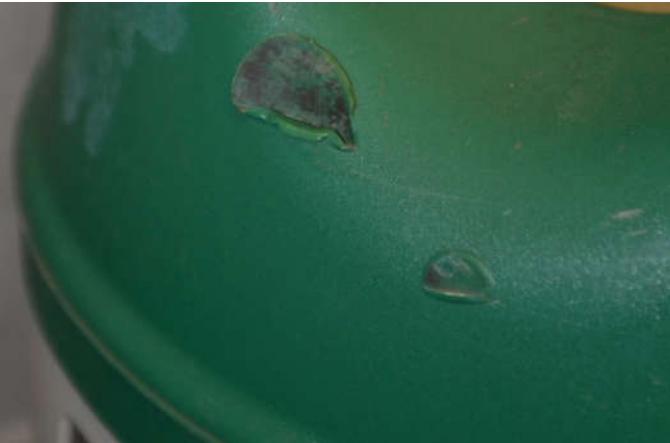
<p><b>Handle part of casting melted due direct exposure to hot object on small area. not close to snap/skirt, no marking damaged, no heat indication on boss or composite</b></p> <p>Photo courtesy of PrestaCylinders</p>	<p><b>Replace handle</b></p>

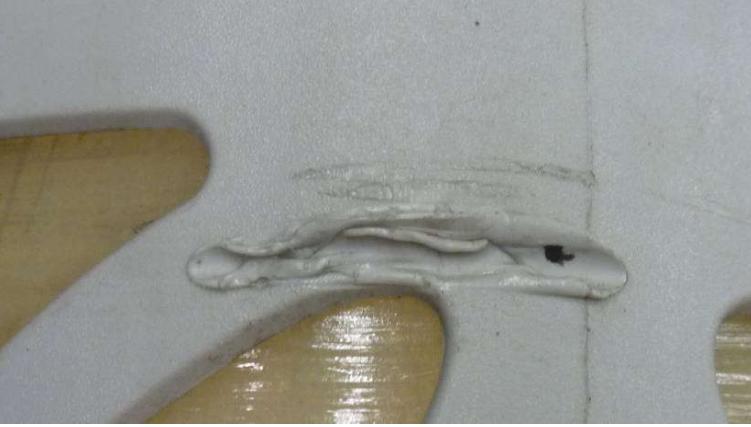
<p><b>Handle and casing lower part melted.</b></p> <p><small>Photo courtesy of PrestaCylinders</small></p>	<b>Reject.</b>

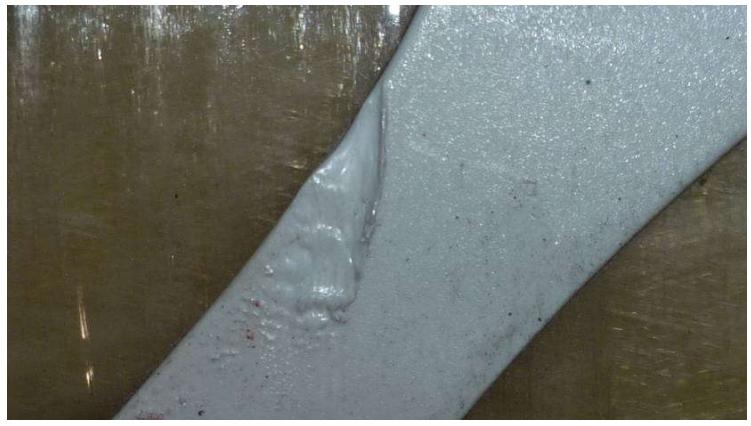
<p><b>Handle and casing lower part melted.</b></p> <p><small>Photo courtesy of PrestaCylinders</small></p>	<b>Reject.</b>

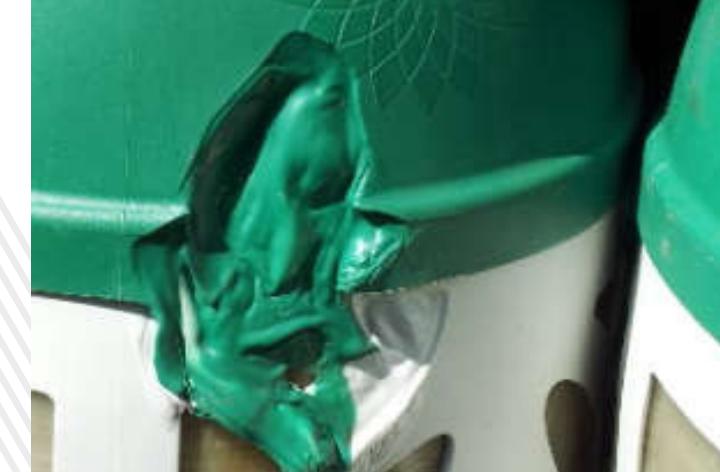
<p><b>Handle and casing lower part melted.</b></p> <p><small>Photo courtesy of PrestaCylinders</small></p>	<b>Reject.</b>

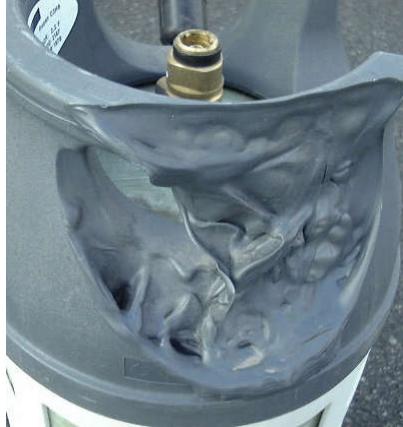
<p><b>Ring and handle melted.</b></p>	<b>Reject</b>

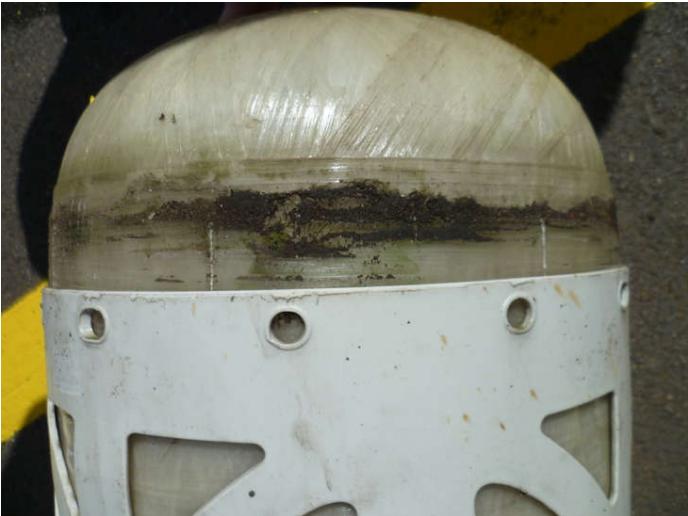
<p><b>Moisture between fiber and casing, no signs of chemical degeneration (no resin soft spots or significant discoloring)</b></p>	<p><b>No action</b></p>

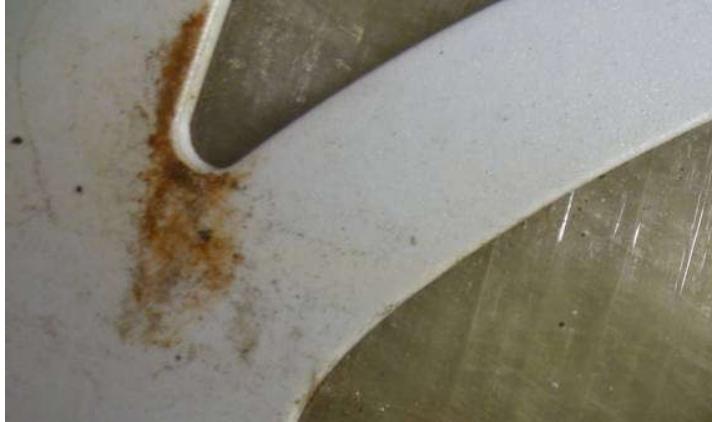
<p><b>Rust on plastic</b></p>	<p><b>No action</b></p>

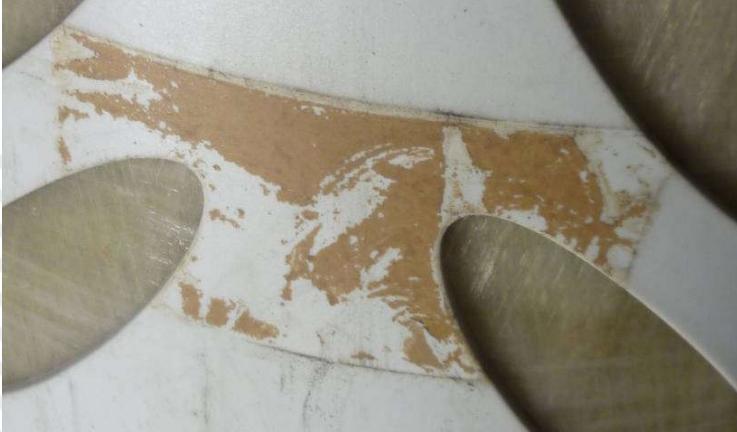
<p><b>Glue from sticker or similar, on casing parts</b></p>	<p><b>No action</b></p>

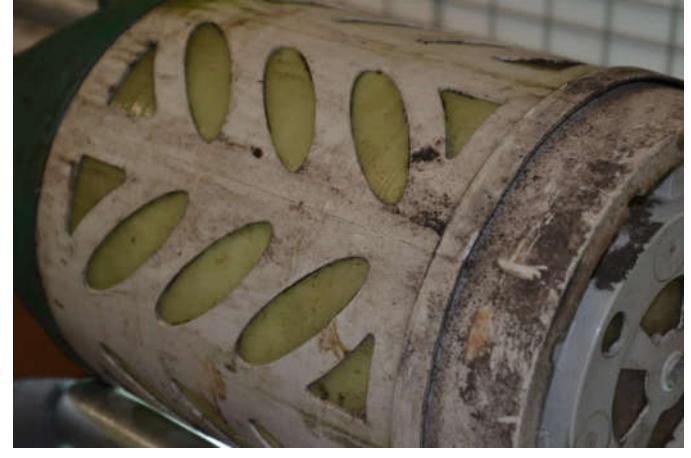
<b>Black dirt</b>	<b>Clean</b>

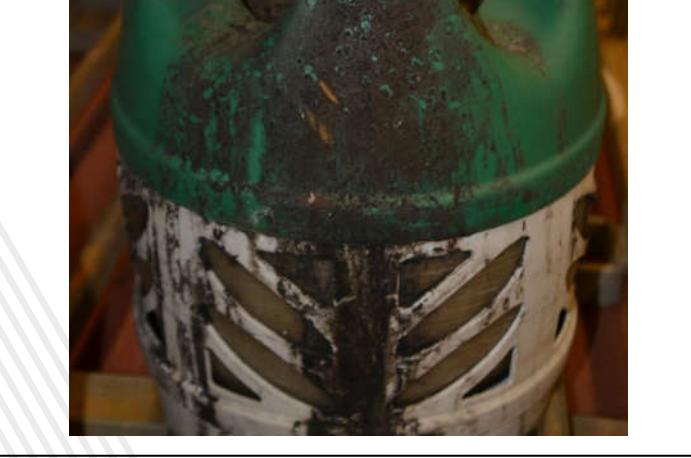
<b>Grease and black dirt</b>	<b>Clean</b>

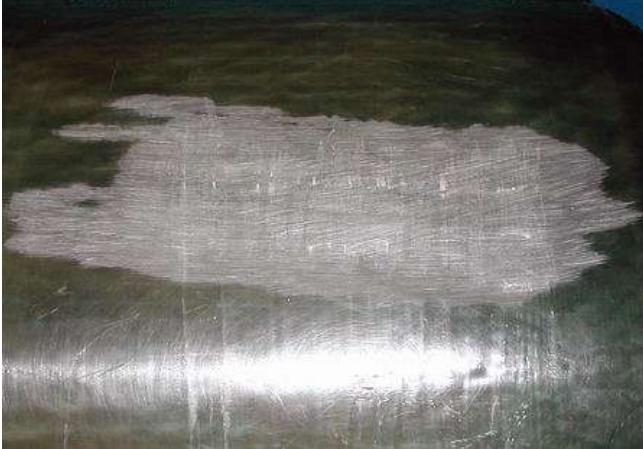
<p><b>Damage from abrasion</b> (Comment: See table in section 7 for details and limits).</p>	<b>Reject</b>

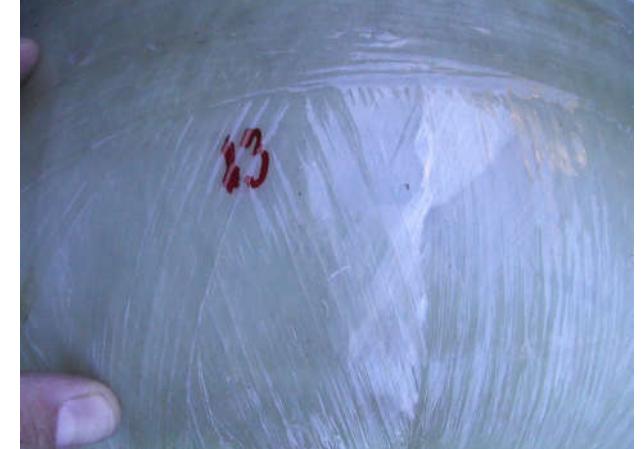
<p><b>Impact damage in combination with de-lamination and surface defects.</b></p>	<b>Reject</b>

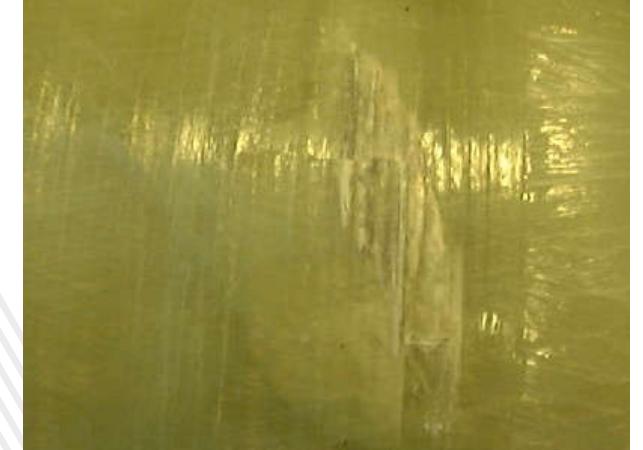
<p><b>Impact damage in combination with de-lamination and surface defects.</b></p>	<b>Reject</b>

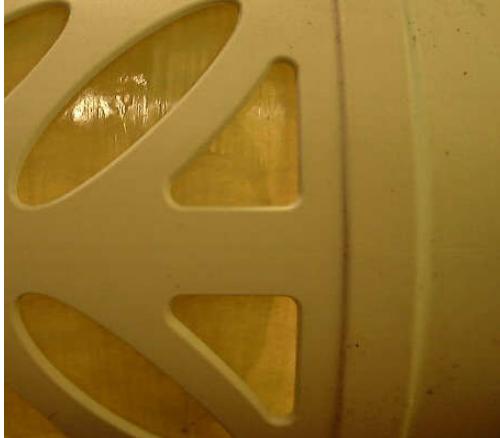
<p><b>Delamination and no surface damage.</b></p>	<p><b>No action</b></p>

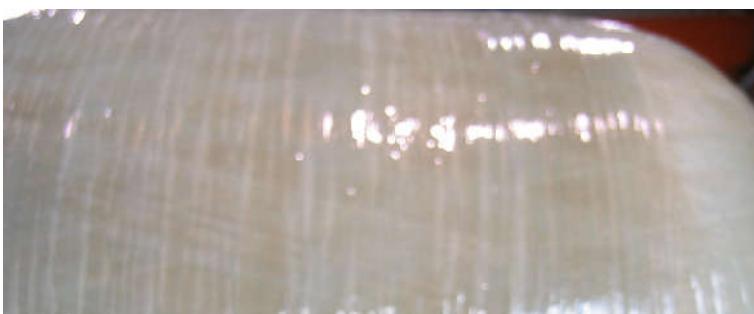
<p><b>Intra-laminar delamination due to pressure cycling &gt;12000 cycles to proof pressure. If less than approximately 100 hairlines, it is acceptable.</b></p>	<p><b>Reject</b></p>

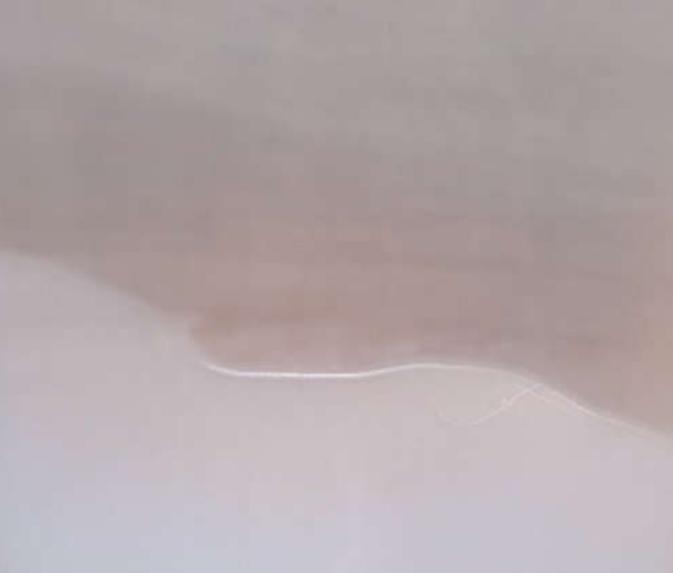
<p>Stretch-mark / white line in the liner at cylindrical / dome transition area (internal inspection). Usually in combination with partial lack of adhesion between liner and composite wrapping.</p>	Reject

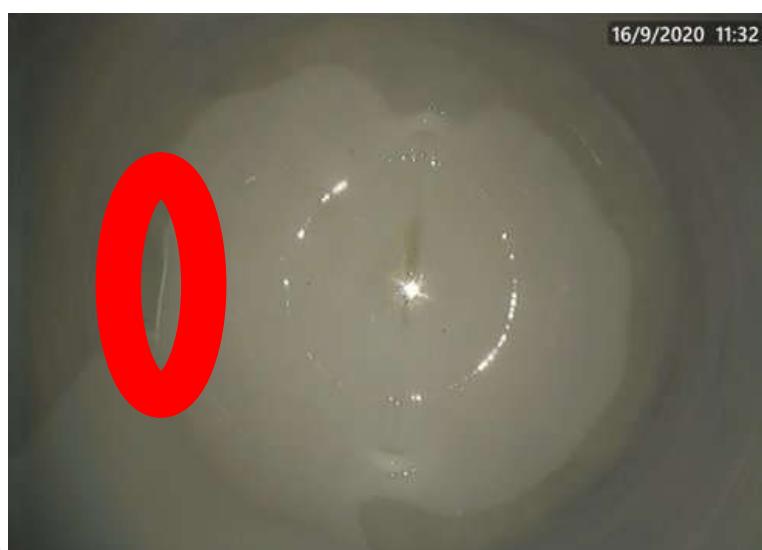
<p>Stretch-mark / white line in the liner at cylindrical / dome transition area (internal inspection). Usually in combination with partial lack of adhesion between liner and composite wrapping (whitish area in the picture).</p>	Reject

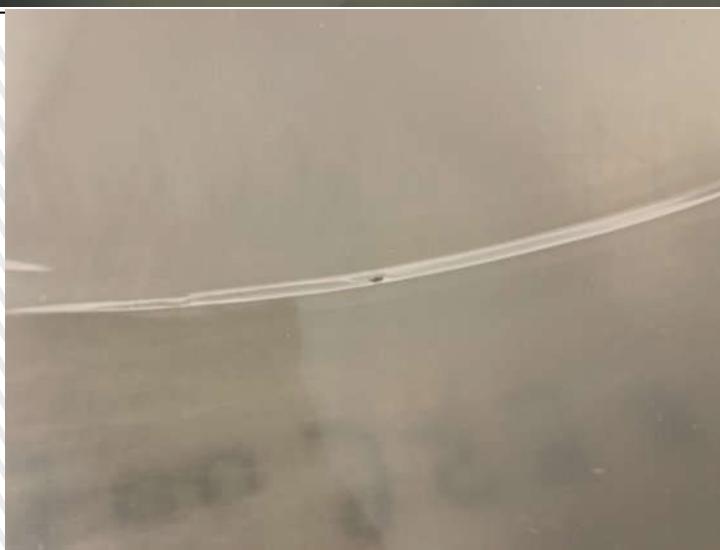
<p>Crack in the liner at cylindrical / dome transition area (internal inspection).</p>	Reject
