# Composite LPG cylinders

## Appendix 1 – Criteria for cylinder inspection

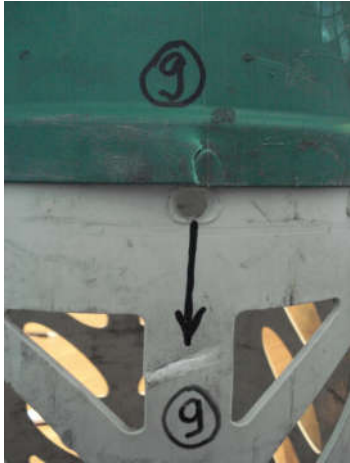
| | <p>Damage on handle "skirt",<br/>and lower part</p> | <p>Replace handle<br/>and casing<br/>lower part.</p> |

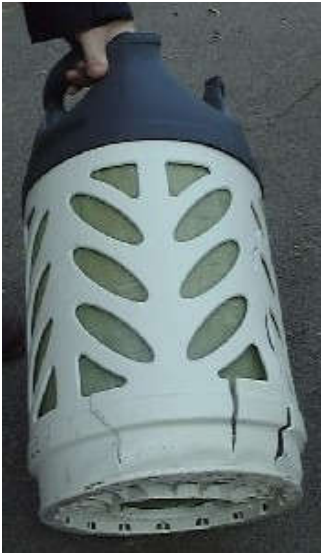
| | <p>Damage on casing lower part.</p> | <p>Replace casing lower part.</p> |

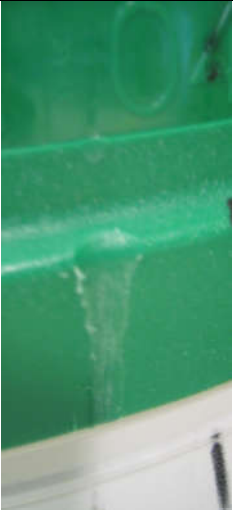
| | <p>Damage on handle "skirt" and potentially casing lower part.</p> | <p>Replace handle and potentially casing lower part.</p> |

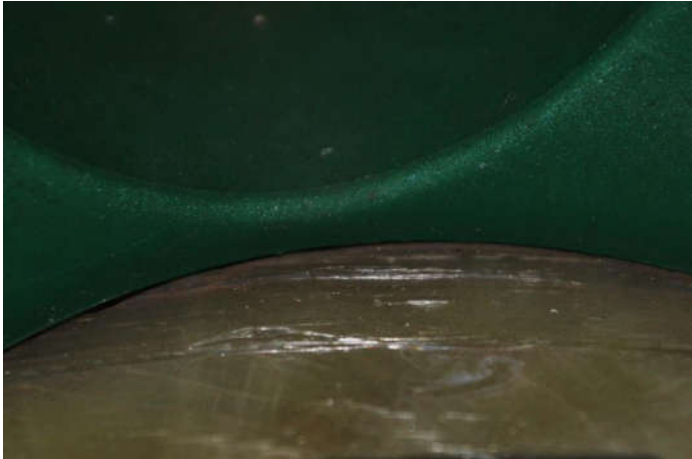
| | <p>Fiber peeled on top</p> | <p><i>No action</i></p> |

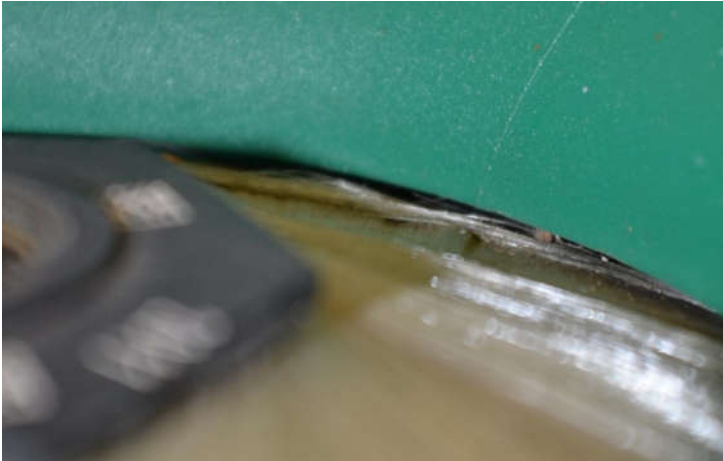
| | <p>Fiber peeled under plastic top part</p> | <p>No action</p> |

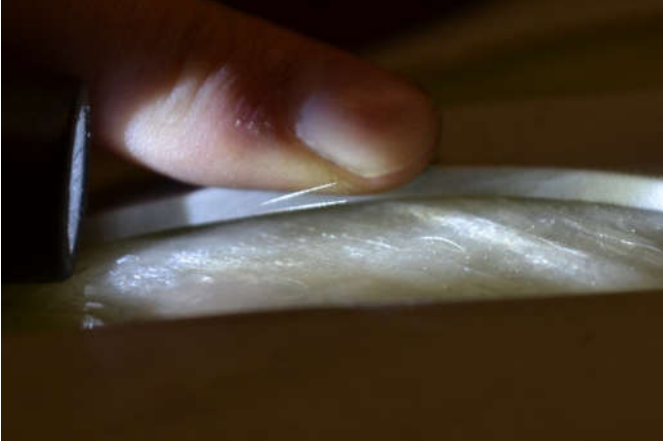
| | <p>Fiber peeled on vertical part</p> | <p>No action</p> |

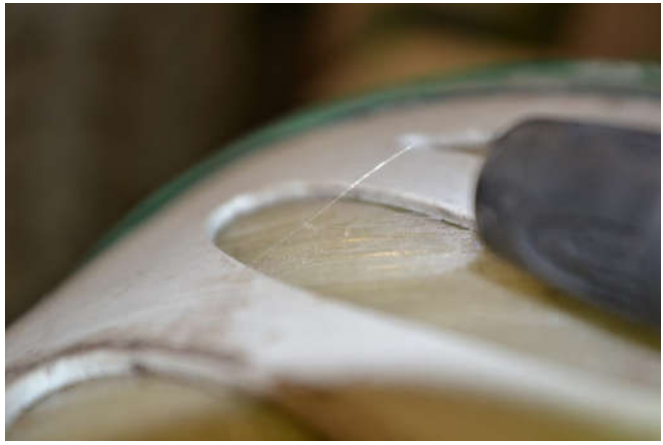
| | <p>Fiber peeled on vertical part</p> | <p>No action</p> |

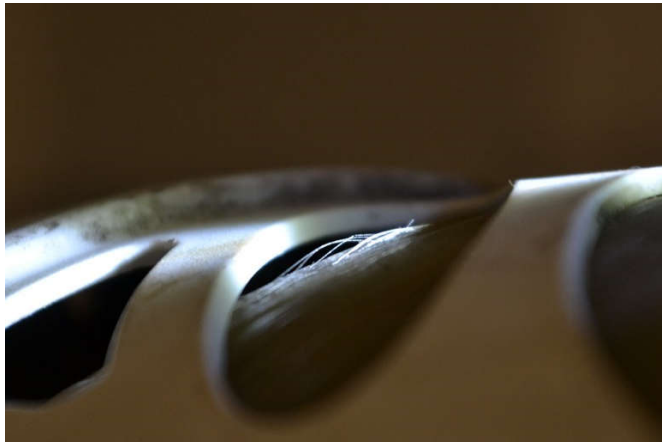
| | <p>Fiber peeled on vertical part</p> | <p>No action</p> |

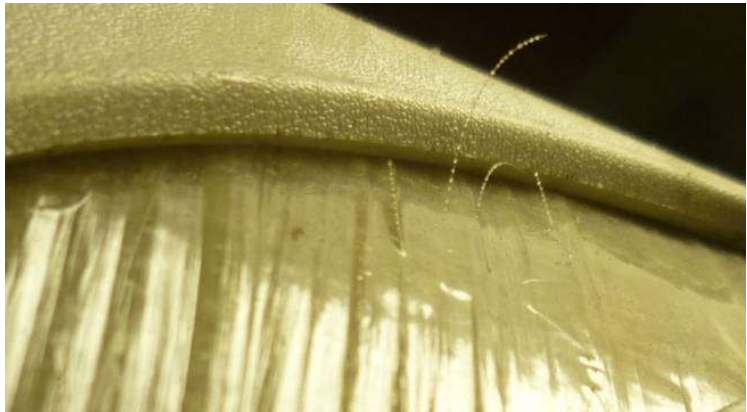
| | <p>Fiber peeled on vertical part</p> | <p>No action</p> |

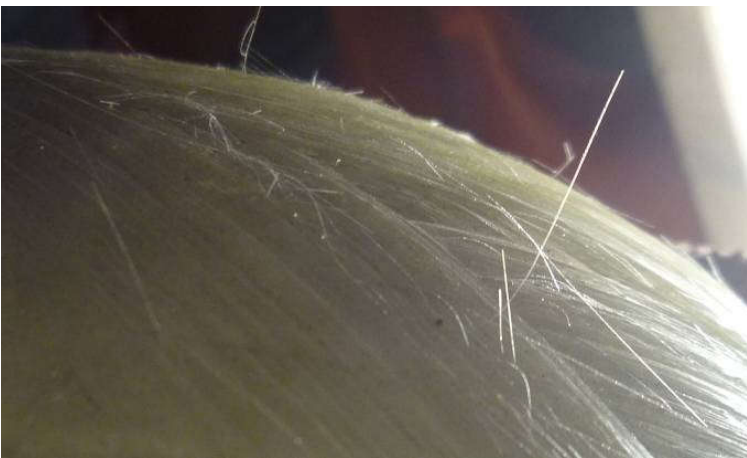
| | <p>Fiber peeled on vertical part</p> | <p>No action</p> |

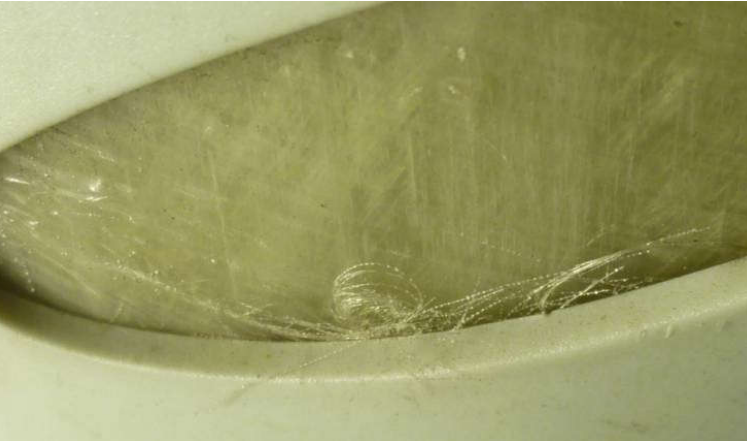
| | <p>Fiber peeled on vertical part</p> | <p>No action</p> |

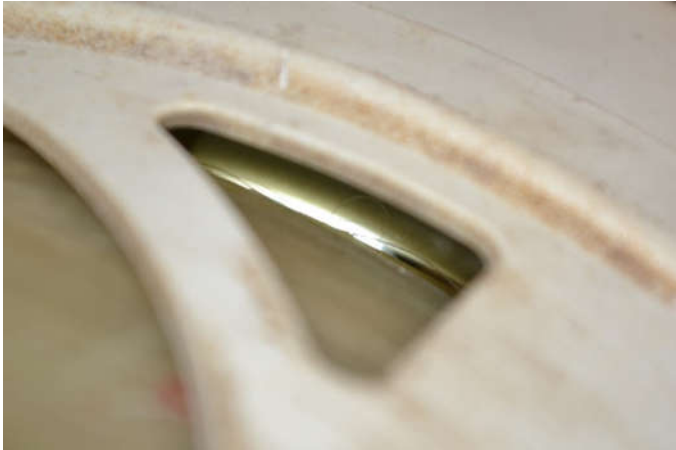
| | <p>Fiber peeled on lower part</p> | <p>No action</p> |

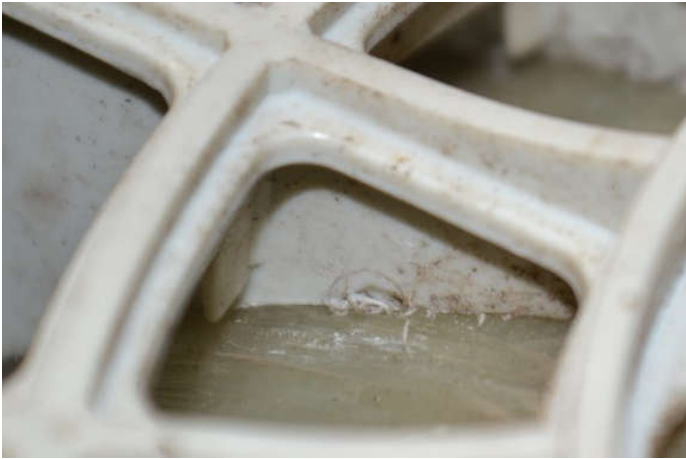
| | <p>Fiber scratched under foot ring</p> | <p>No action</p> |

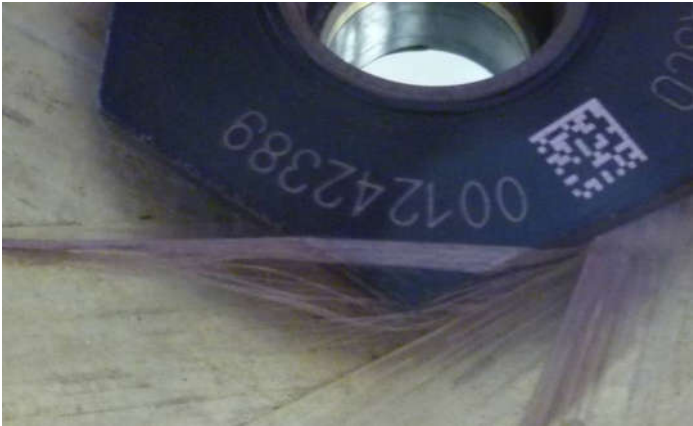
| | <p>Fiber dried and brittle on flange</p> | <p>No action</p> |

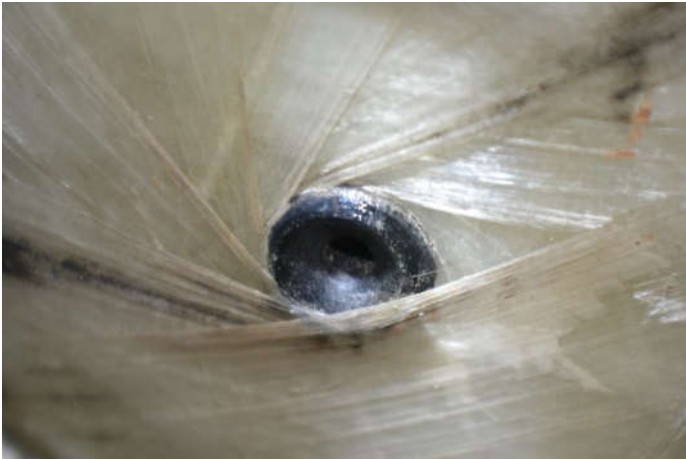
| | <p>Fiber dried and brittle on centering piece</p> | <p>No action</p> |

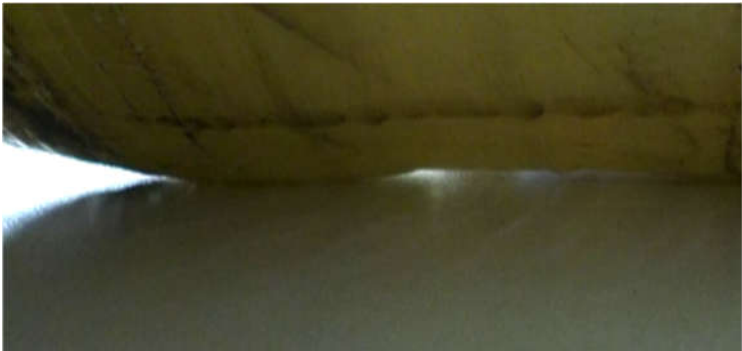
| | <p>Waves on composite side wall from production.</p> | <p>No action</p> |

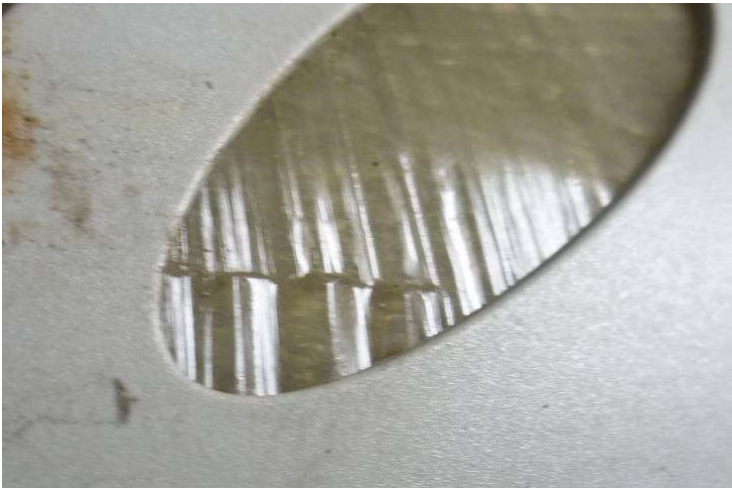
| | <p>Small edge from “fiber stop / end” during manufacturing</p> | <p>No action</p> |

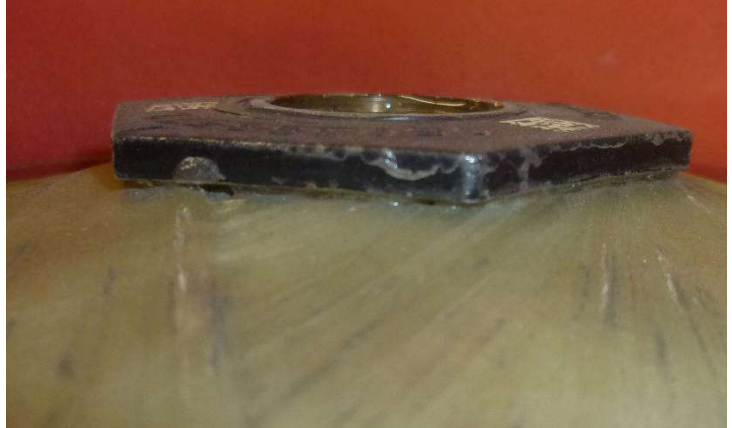
| | <p>Hexagonal flange touching composite (normal)</p> | <p>No action</p> |

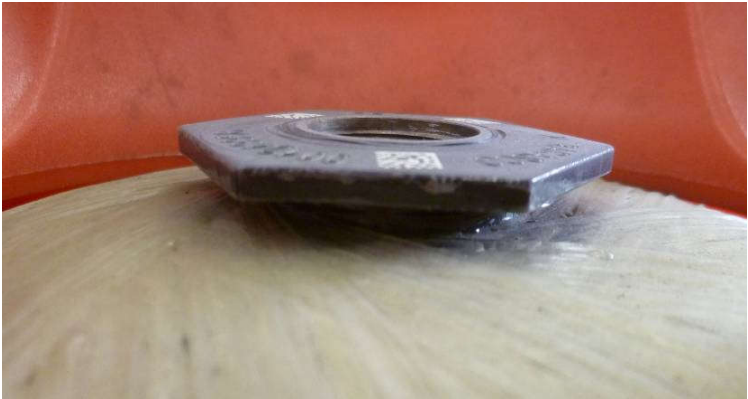
| | <p>Resin and laminate build up under boss is within the in the low side of the tolerance.</p> | <p>No action</p> |

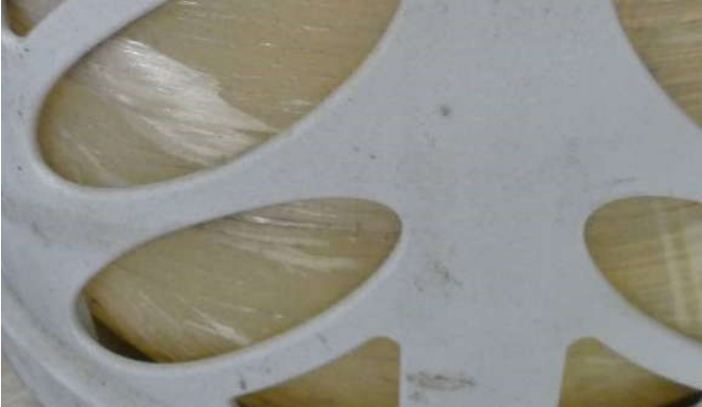
| | <p>Lack of surface resin on fiber<br/>(Comment: This low quality photo does not illustrate the situation well...)</p> | <p>No action</p> |

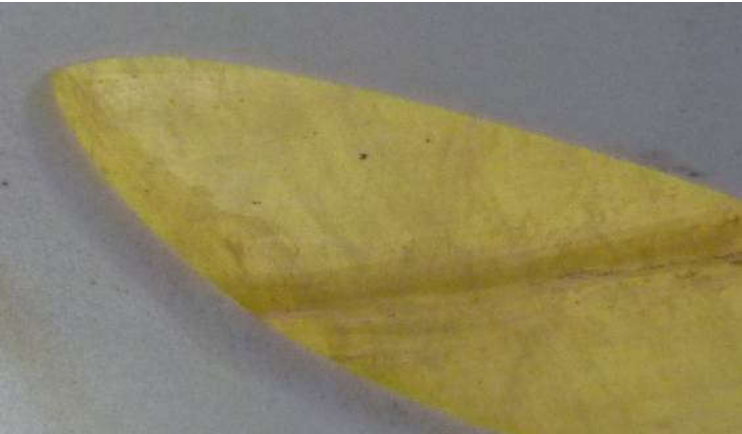
| | <p>Fiber tow standing somewhat out</p> <p>Photo courtesy of PrestaCylinders</p> | <p>No action</p> |

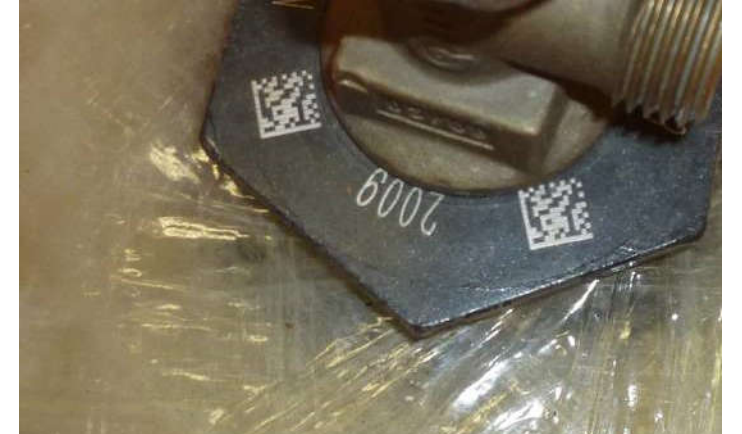
| | <p>Excess thickness of resin (normal).</p> <p>Photo courtesy of PrestaCylinders</p> | <p>No action</p> |

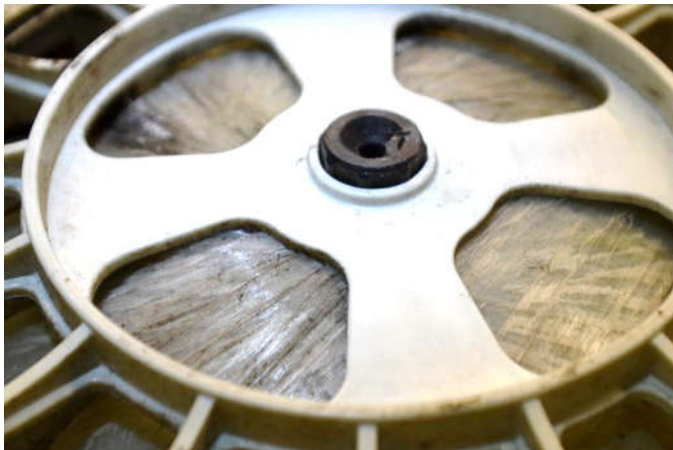
| | <p>Resin and laminate build up within the bottom is in the in the low side of the tolerance.</p> <p><small>Photo courtesy of PrestaCylinders</small></p> | <p>No action</p> |

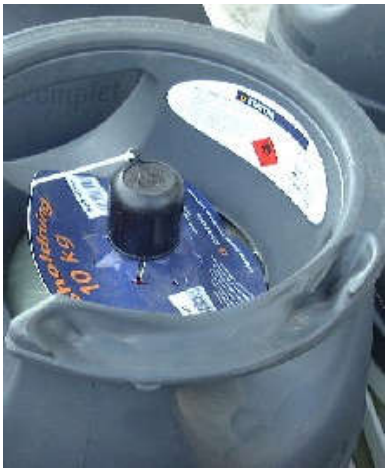
| | <p>Ring and possibly handle melted, less than 30 mm below the interface between ring and handle. No indication of heat on boss and composite</p> | <p>Replace handle</p> |

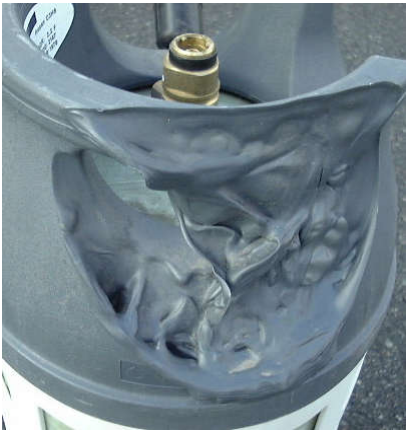
| | <p>Ring and handle melted.</p> | <p>Reject</p> |

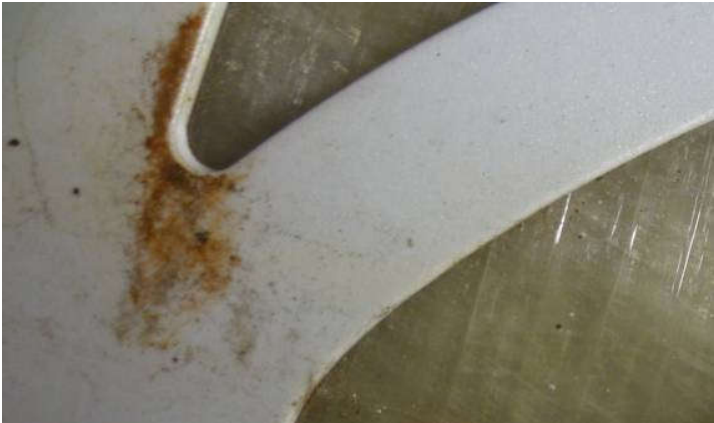
| | <p>Rust on plastic</p> | <p>No action</p> |

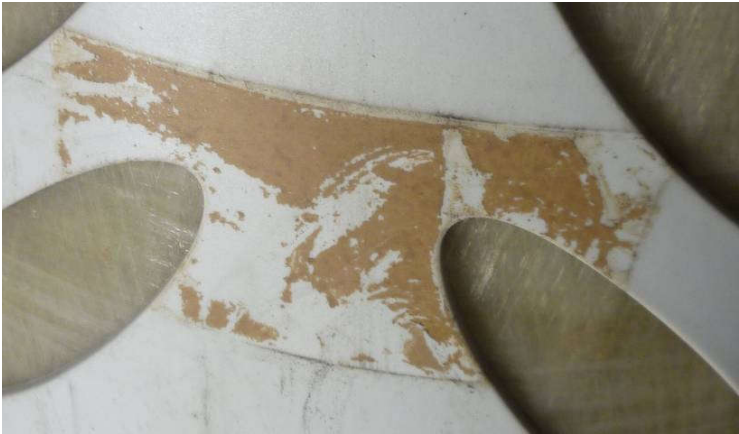
| | <p>Glue from sticker or similar, on casing parts</p> | <p>No action</p> |

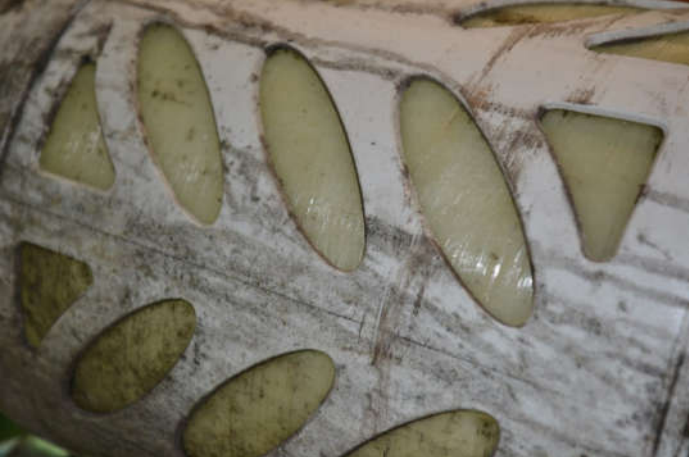
| | <p>Black dirt</p> <p>Photo courtesy of<br/>PrestaCylinders</p> | <p>Clean</p> |

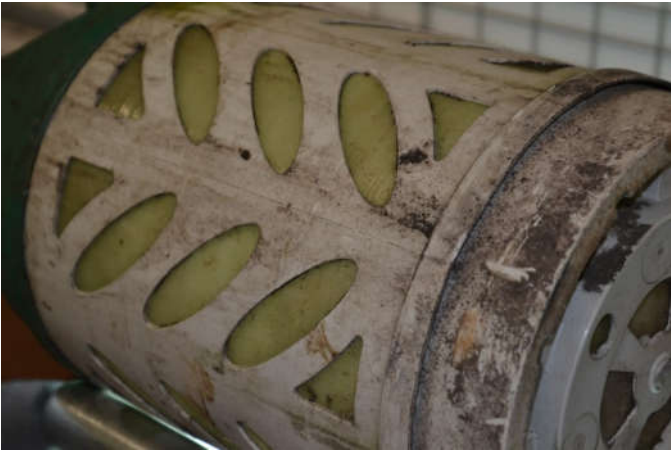
| | <p>Grease and black dirt</p> <p>Photo courtesy of<br/>PrestaCylinders</p> | <p>Clean</p> |

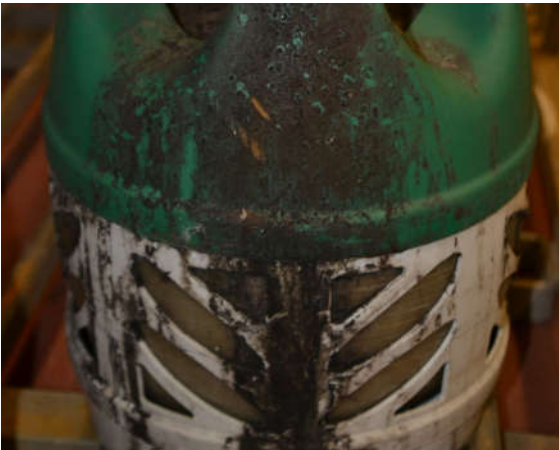
| | <p>Grease</p> <p>Photo courtesy of<br/>PrestaCylinders</p> | <p>Clean</p> |

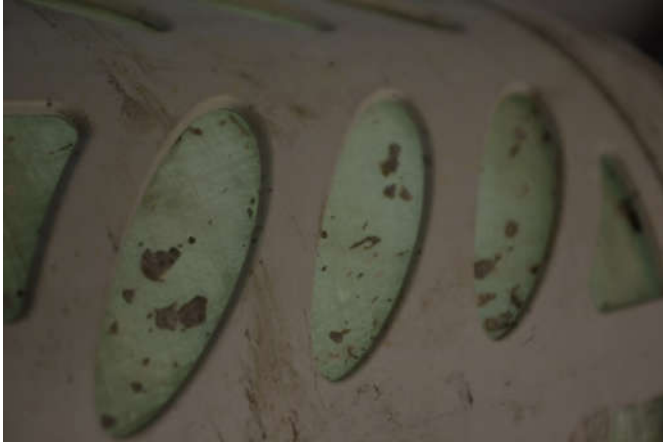
| | Cement | Clean |

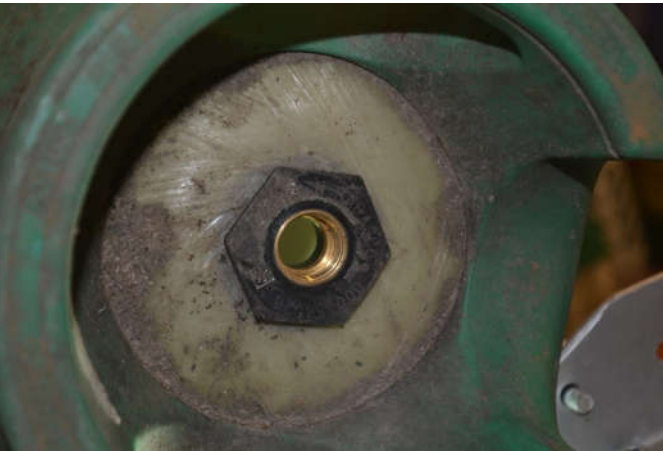
| | Lot of dirt | Clean |

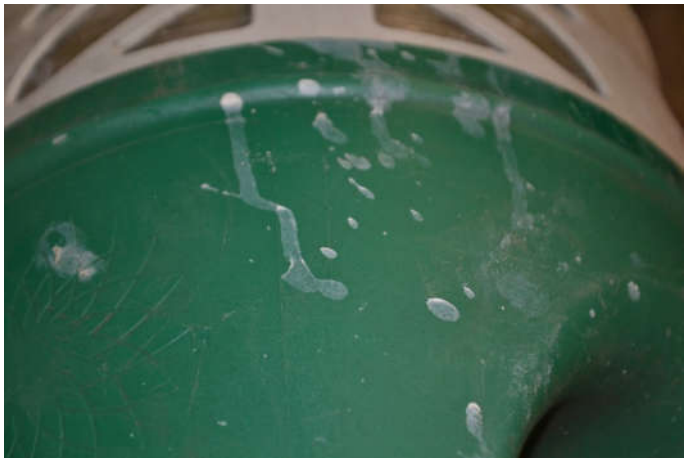
| | Paint | No action |

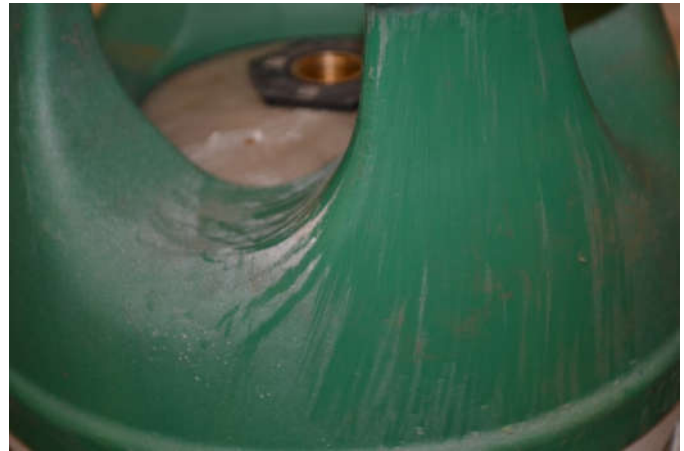
| | Light spray | No action |

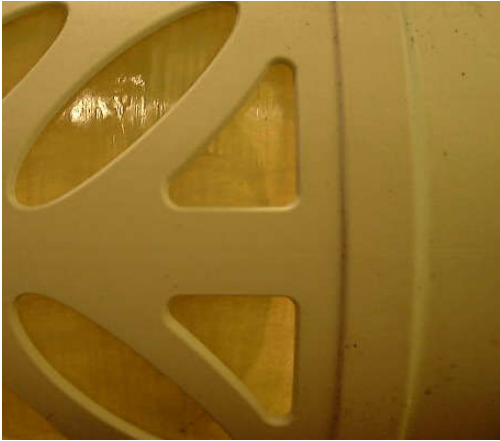
| | <p>Delamination and no surface damage.</p> | <p>No action</p> |

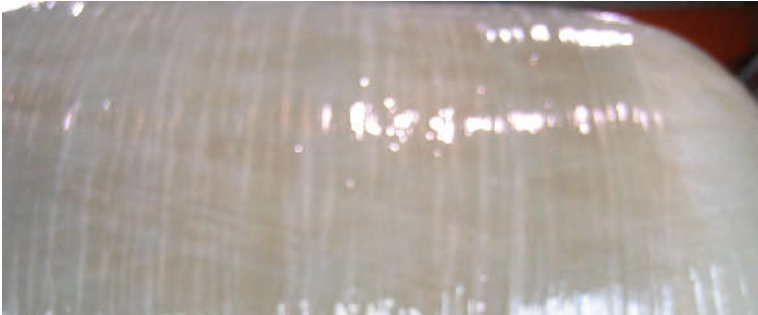
| | <p>Intra-laminar delamination due to pressure cycling &gt;12000 cycles to proof pressure<br/>If less than approximately 100 hairlines, it is acceptable.</p> | <p>Reject</p> |
