Ragasco Composite Propane Cylinders

# Appendix 1 - Criteria for Cylinder Inspection

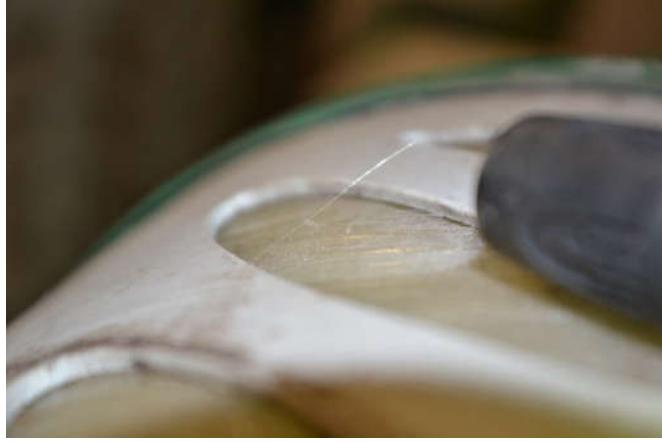
<p><b>Fiber peeled on vertical part</b></p>	<p>No action</p>

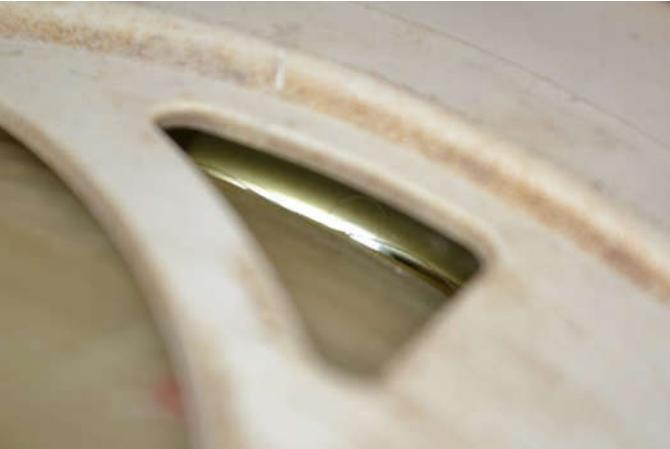
<p><b>Fiber peeled on lower part</b></p> <p><small>Photo courtesy of PrestaCylinders</small></p>	<b>No action</b>

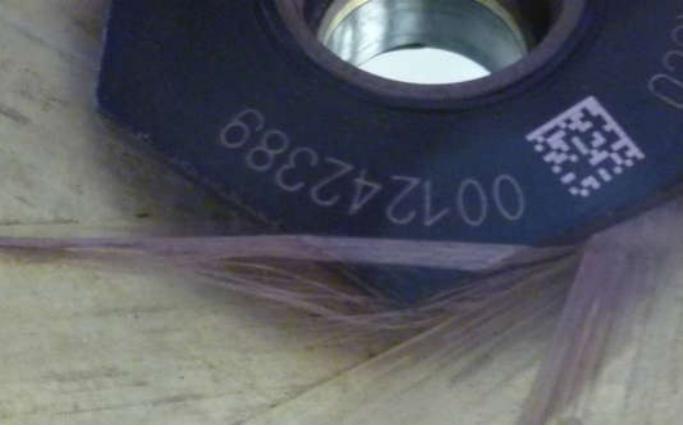
<p><b>Fiber dried and brittle on flange</b></p>	<p><b>No action</b></p>

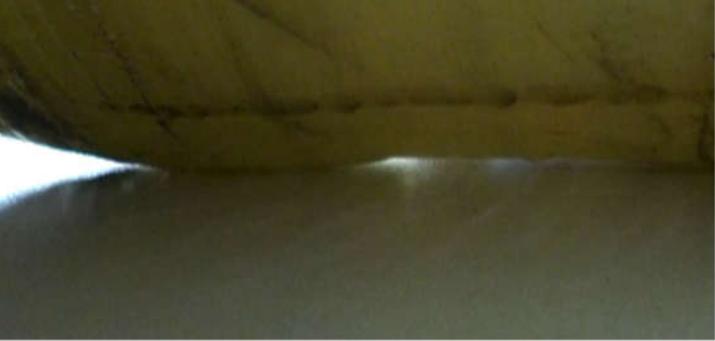
<p><b>Waves on composite side wall from production.</b></p>	<p><b>No action</b></p>

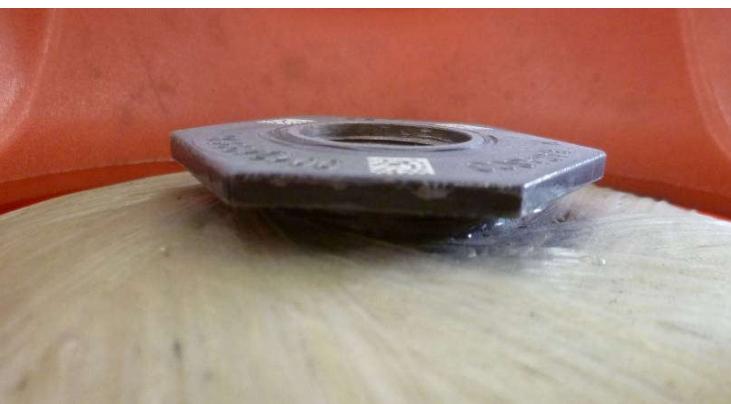
<p><b>Resin and laminate build up under boss is within the in the low side of the tolerance.</b></p> <p><small>Photo courtesy of PrestaCylinders</small></p>	<b>No action</b>

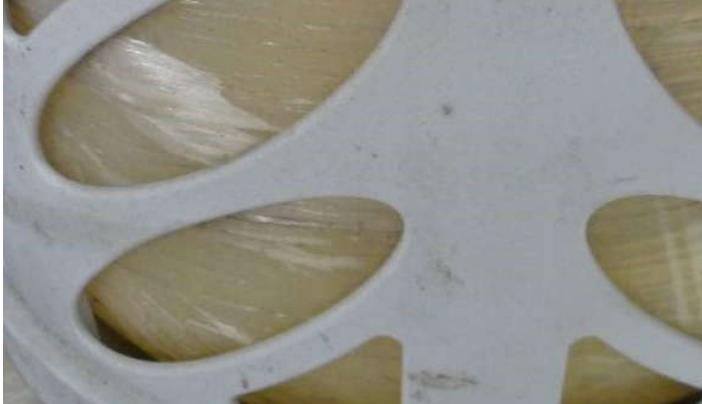
<p><b>Lack of surface resin on fiber (Comment: This low quality photo does not illustrate the situation well...)</b></p>	<p>No action</p>

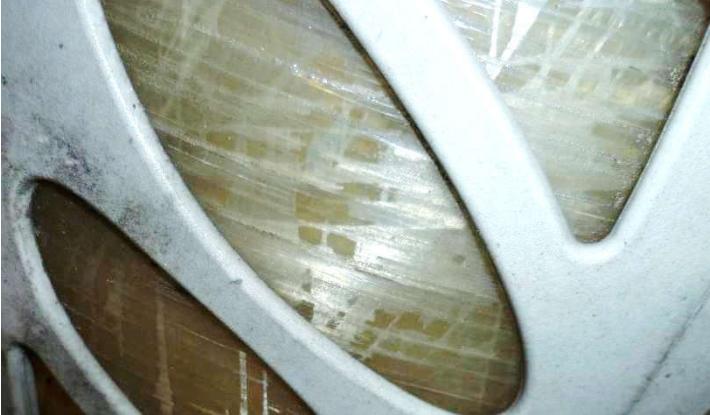
<p><b>Air to in the surface layer of composite, not into the lower layers.</b></p>	<p>Area less than 60mm x 60mm = No action.</p>

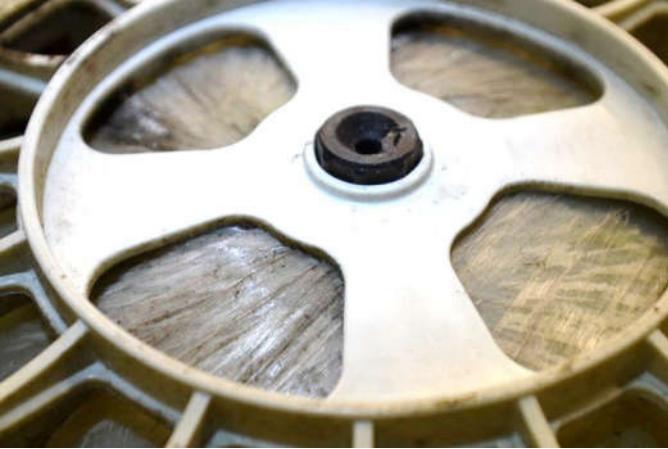
<p><b>Resin and laminate build up within the bottom is in the in the low side of the tolerance.</b></p> <p><small>Photo courtesy of PrestaCylinders</small></p>	<p>No action</p>

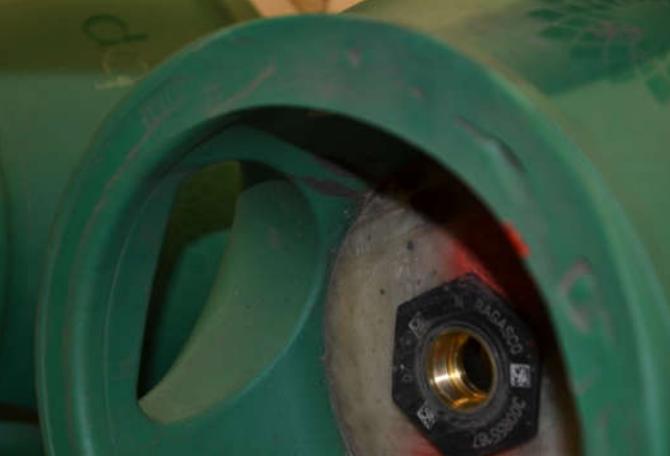
<p><b>Ring and handle part melted, no heat indication on boss or composite.</b></p>

<p>Photo courtesy of PrestaCylinders</p>	<p><b>Replace ring and handle.</b></p>

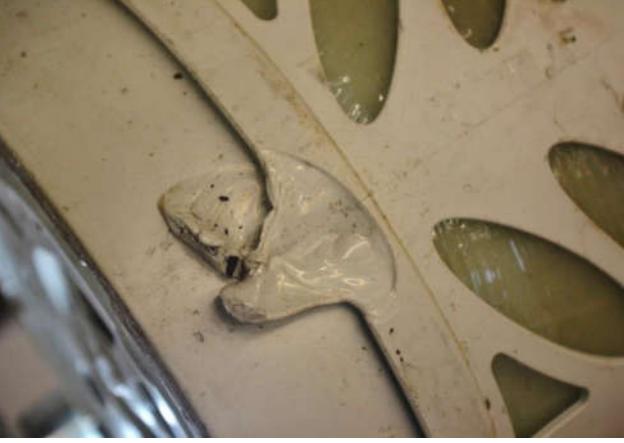
<p><b>Casing lower part melted.</b></p> <p><small>Photo courtesy of PrestaCylinders</small></p>	<b>Reject</b>

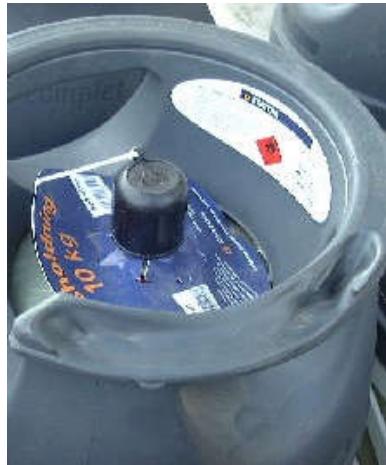
<p><b>Ring and possibly handle melted, less than 30 mm below the interface between ring and handle. No indication of heat on boss and composite</b></p>

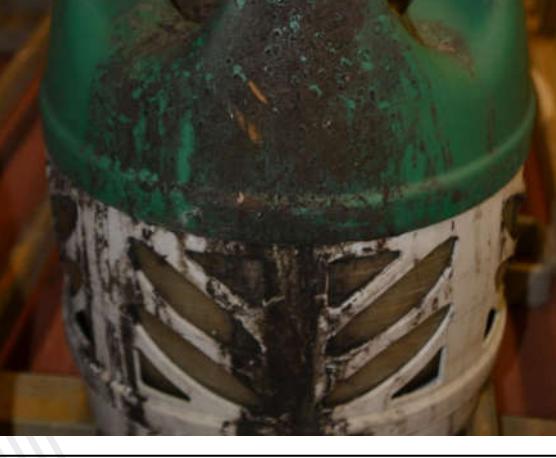
<b>Grease</b>	<b>Clean</b>

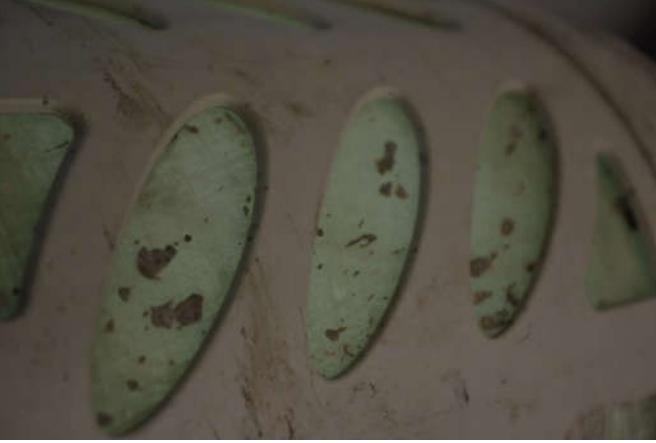
<b>Cement</b>	<b>Clean</b>

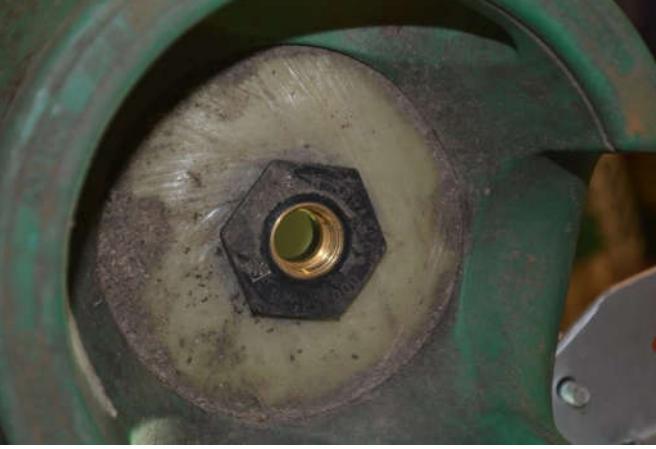
<b>Lot of dirt</b>	<b>Clean</b>

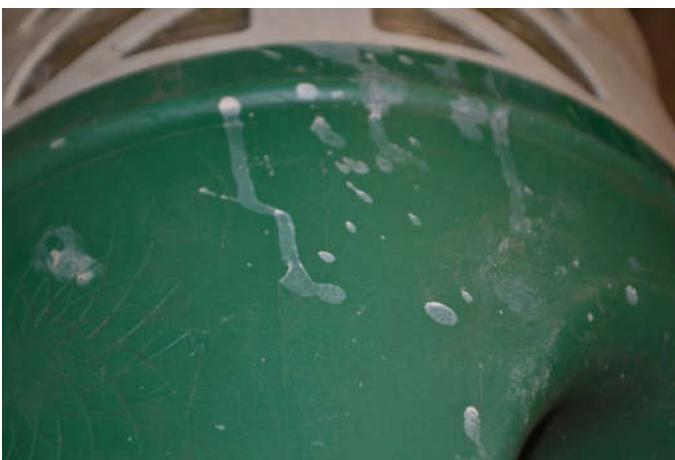
<b>Paint</b>	<b>No action</b>

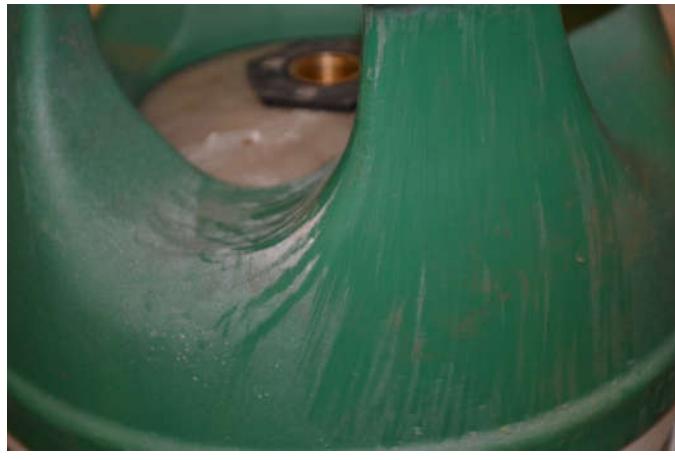
<b>Light spray</b>	<b>No action</b>

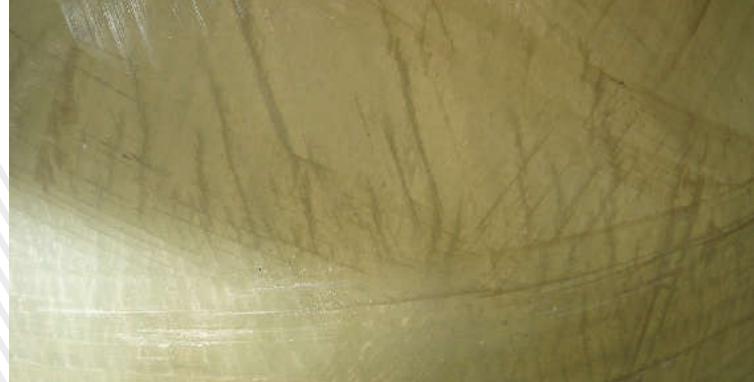
<p><b>Intra-laminar delamination due to pressure cycling &gt;12000 cycles to proof pressure. If less than approximately 100 hairlines, it is acceptable.</b></p>	<p><b>Reject</b></p>
